Company SBI GENERAL INSURANCE

Customer SATYESH BRINE CHEM PVT LTD.

Measuring Date:- 10/11/2021

Task:- This examination was carried out according to EN 13187 using a thermal imager.

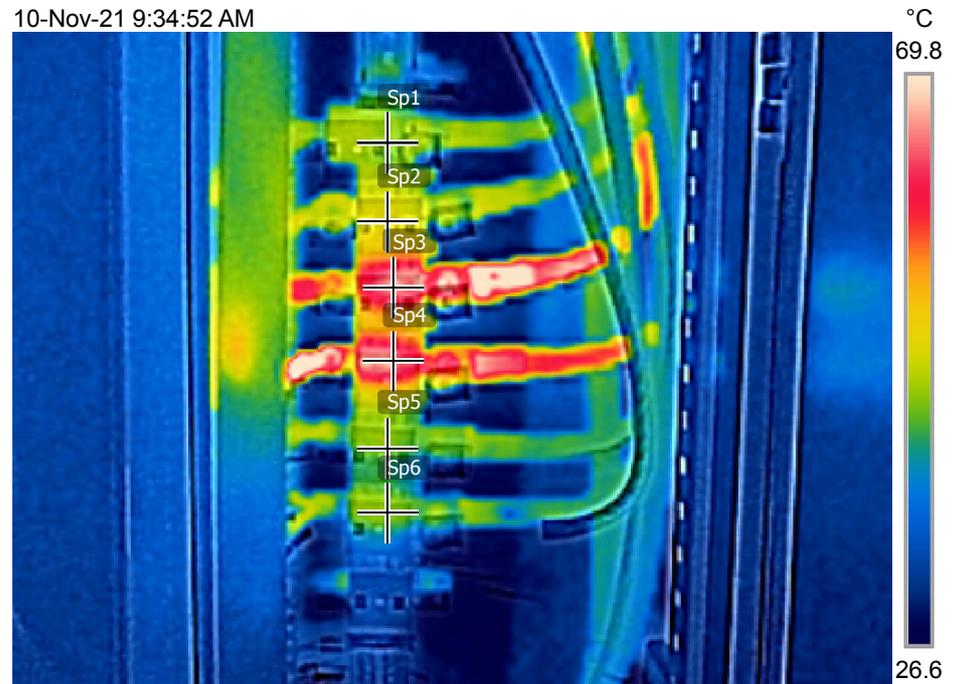
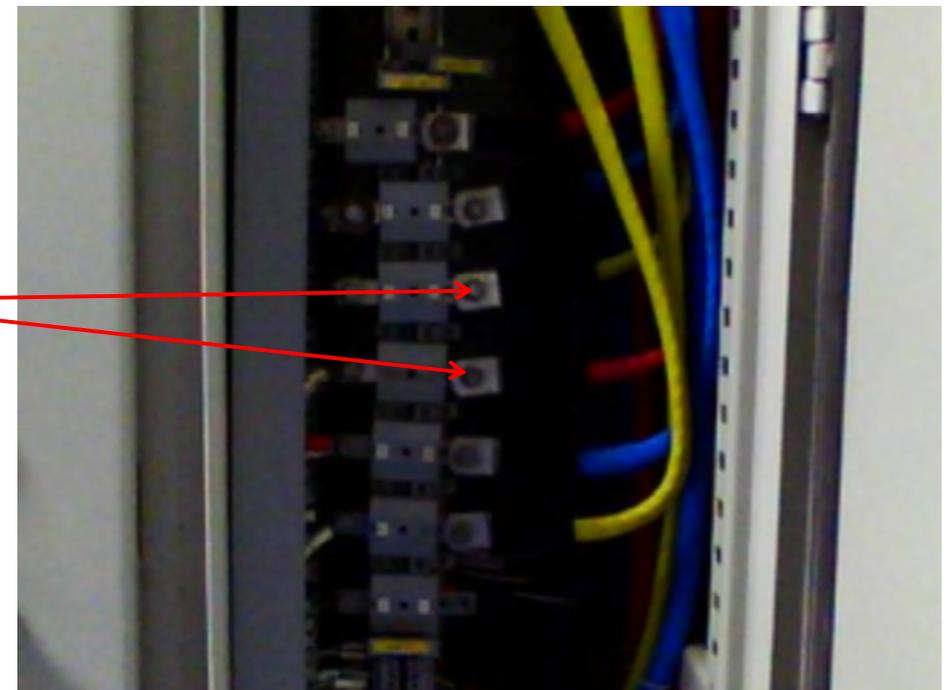
Location:- 5F MCC Panel

Sp1	33.2 °C
Sp2	36.5 °C
Sp3	63.7 °C
Sp4	63.7 °C
Sp5	32.8 °C
Sp6	33.1 °C

Note:- High temp observed on sp3 and sp4 so please check for tightness of nut bolts and crimping of lugs.

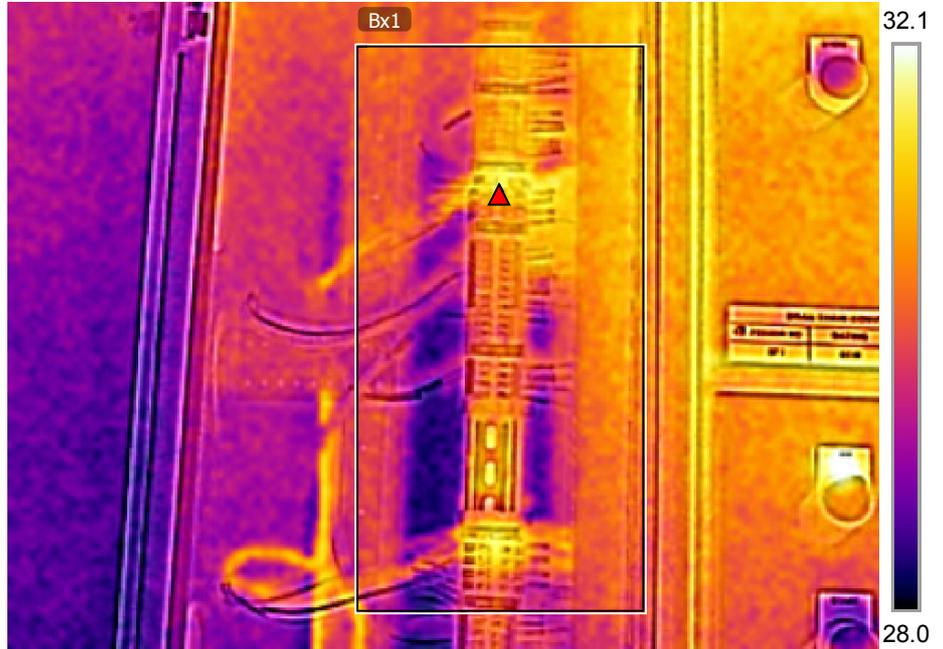
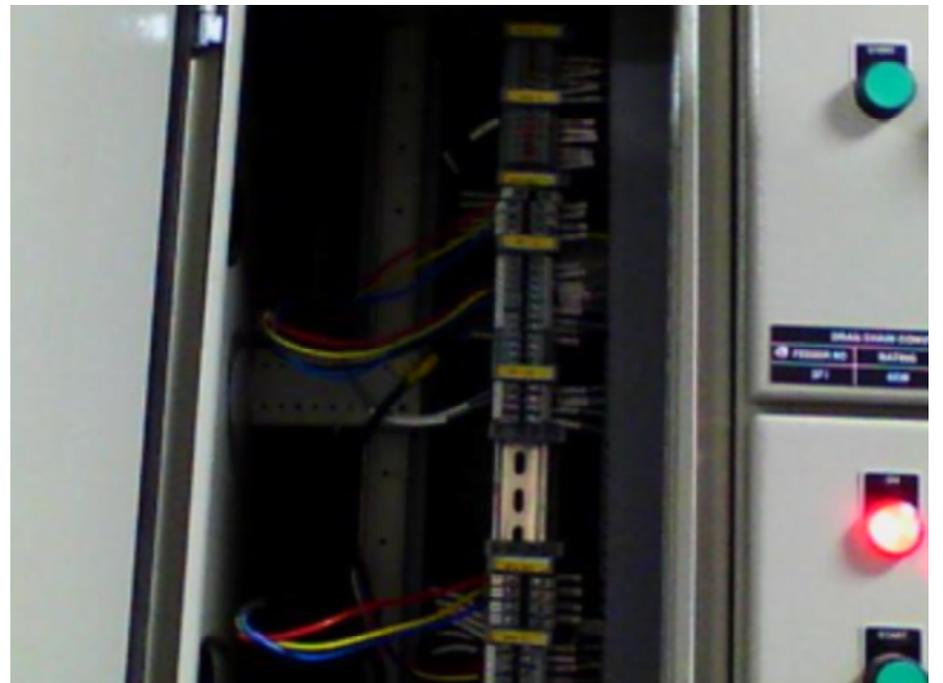
Location:- 1F MCC Panel

Bx1	Max	31.5 °C
-----	-----	---------

Note:- Maximum temp on 1F MCC Panel is 31.5°C, which is found normal.

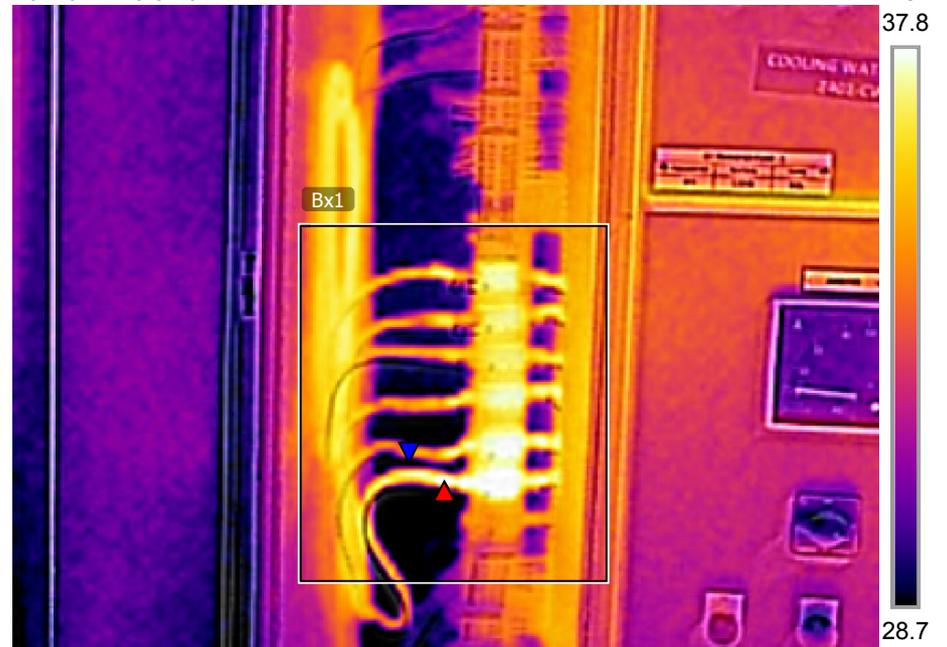
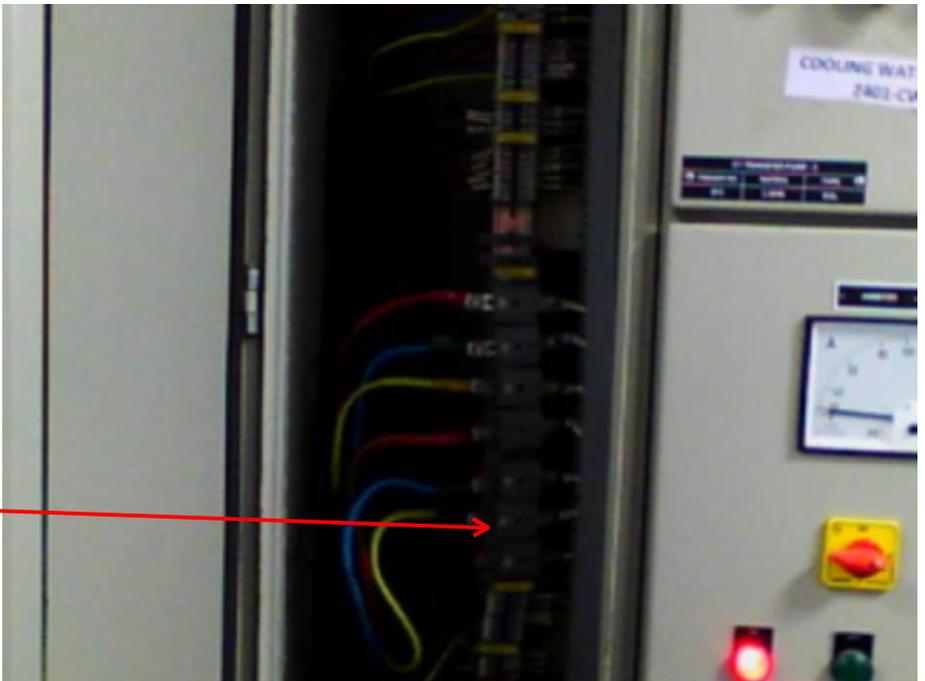
Location:- Mcc Panel

Bx1	Max	42.2 °C
	Min	27.9 °C
	Average	32.4 °C

Note:- Maximum temp on 1F MCC Panel is 42.2°C, which is found normal.

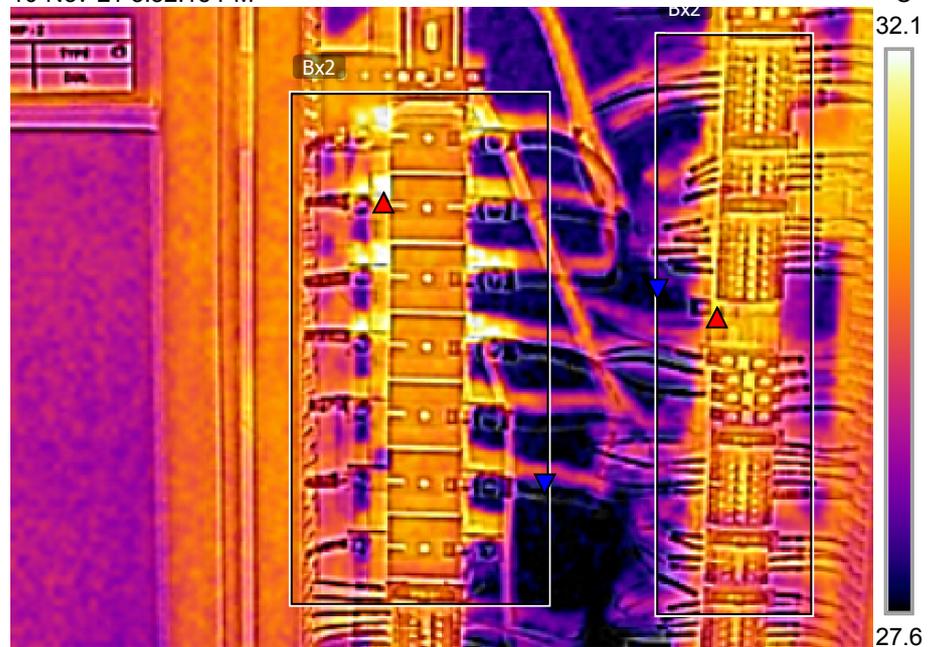
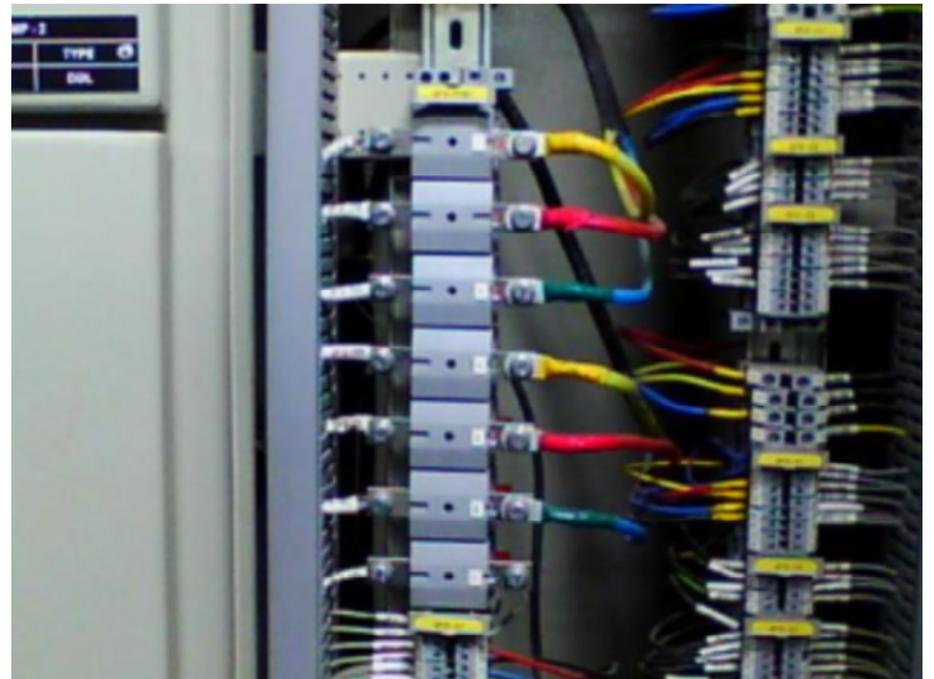
Location:- 3F MCC Panel

Bx2	Max	33.8 °C
	Min	27.4 °C
	Average	29.6 °C
Bx2	Max	30.9 °C
	Min	27.5 °C
	Average	29.6 °C

Note:- Maximum temp on 3F MCC Panel is 33.8°C, which is found normal.

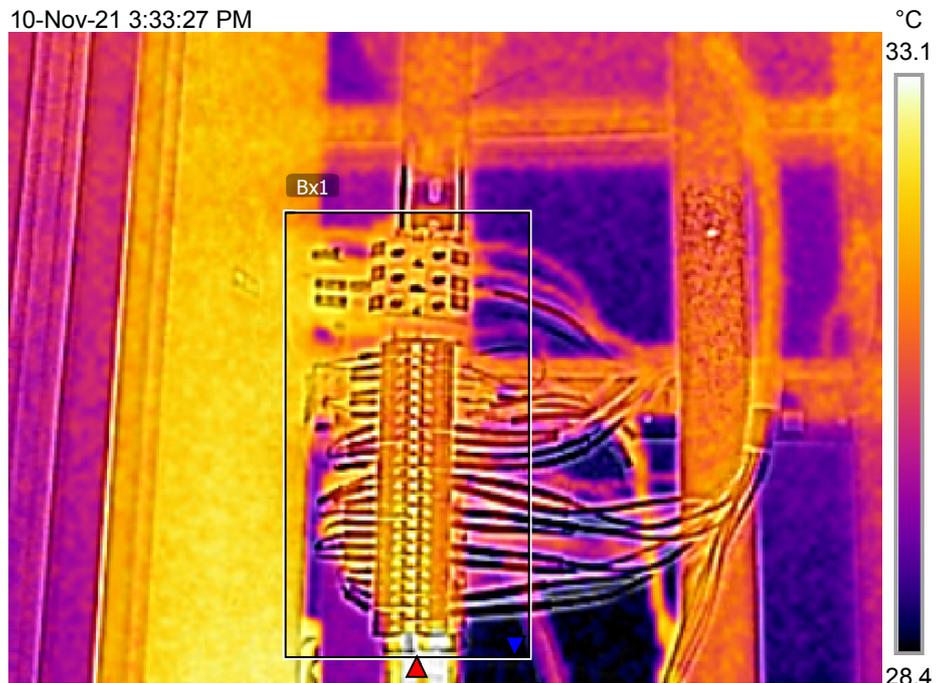
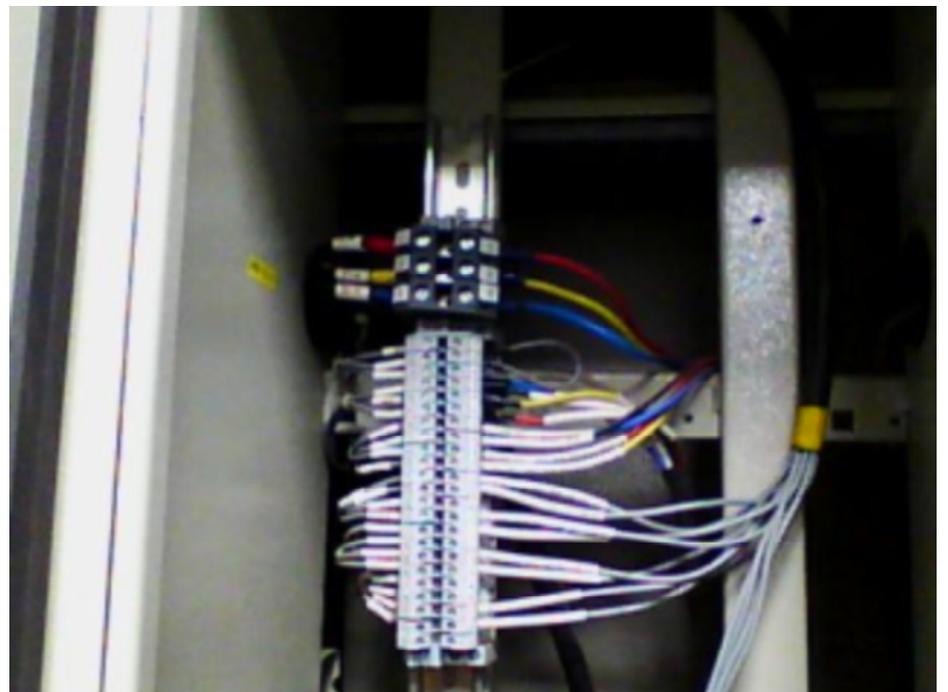
Location:- TG 1F Top MCC Panel

Bx1	Max	34.2 °C
	Min	28.2 °C
	Average	30.7 °C

Note:- Maximum temp on TG 1F TOP MCC Panel is 34.2°C, which is found normal.

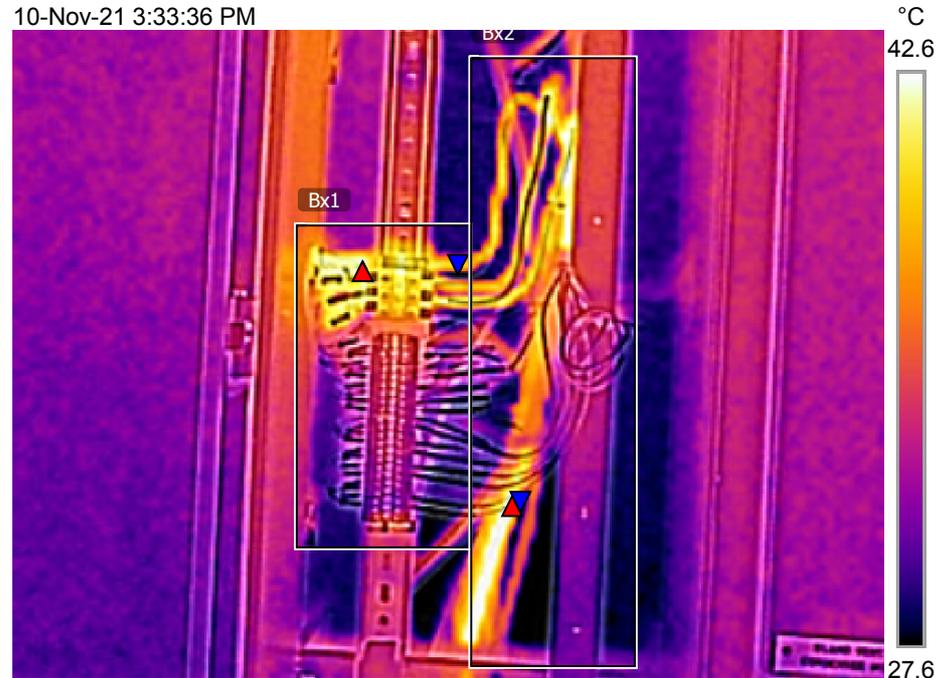
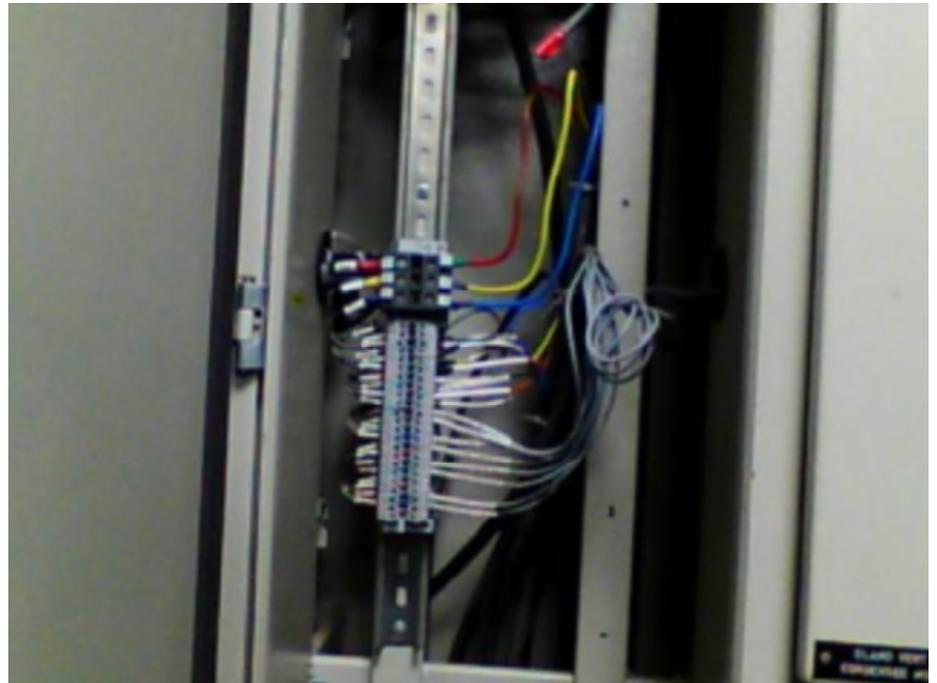
Location:- TG 1F Bottom MCC Panel

Bx1	Max	42.3 °C
	Min	27.3 °C
	Average	30.7 °C
Bx2	Max	47.1 °C
	Min	26.9 °C
	Average	30.5 °C

Note:- Maximum temp on TG 1F Bottom MCC Panel Bx 2 is 47.1°C, which is found normal.

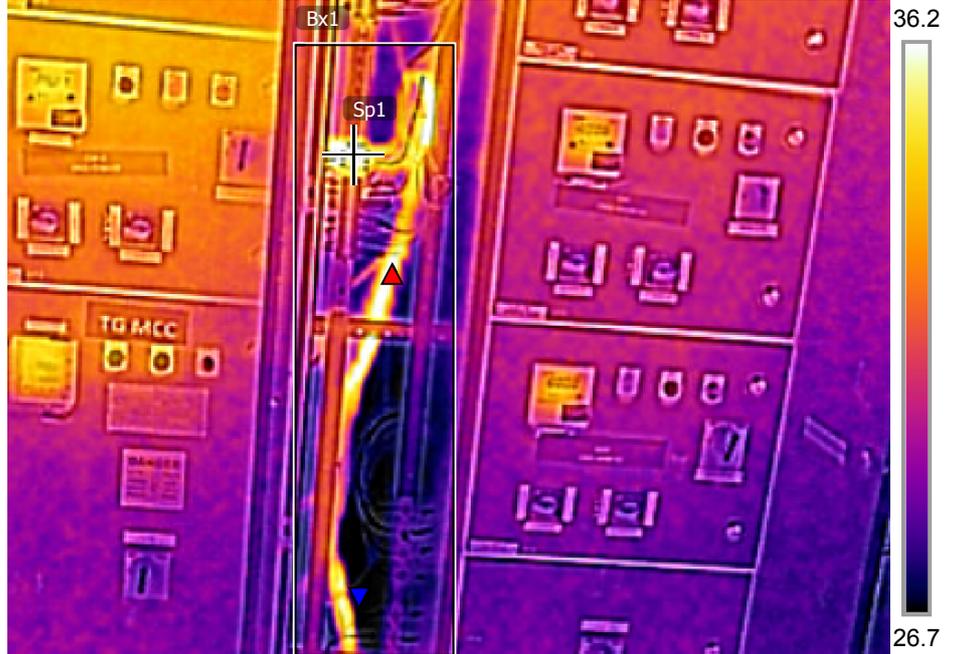
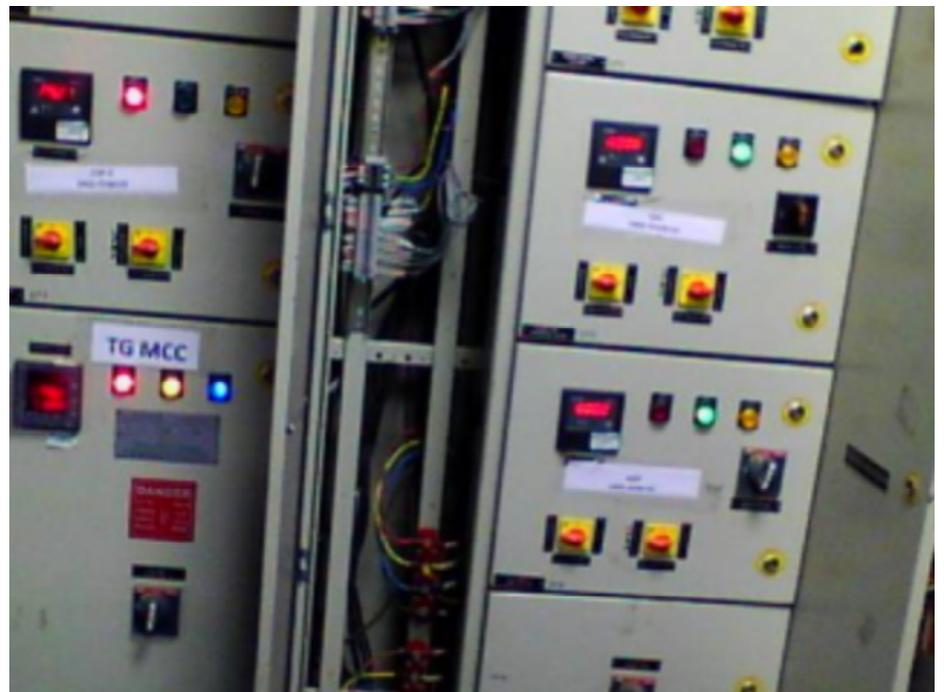
Location:- TG 1F Overview MCC Panel

Bx1	Max	40.7 °C
	Min	26.1 °C
	Average	29.0 °C
Sp1		37.0 °C

Note:- Maximum temp on TG 1F MCC Overview Panel is 31.5°C, which is found normal.

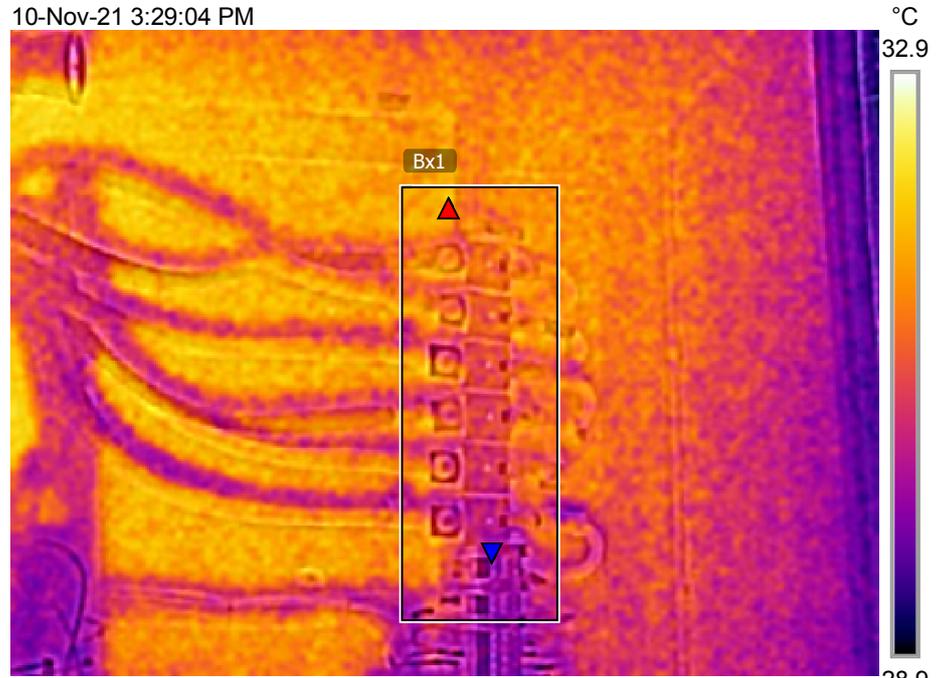
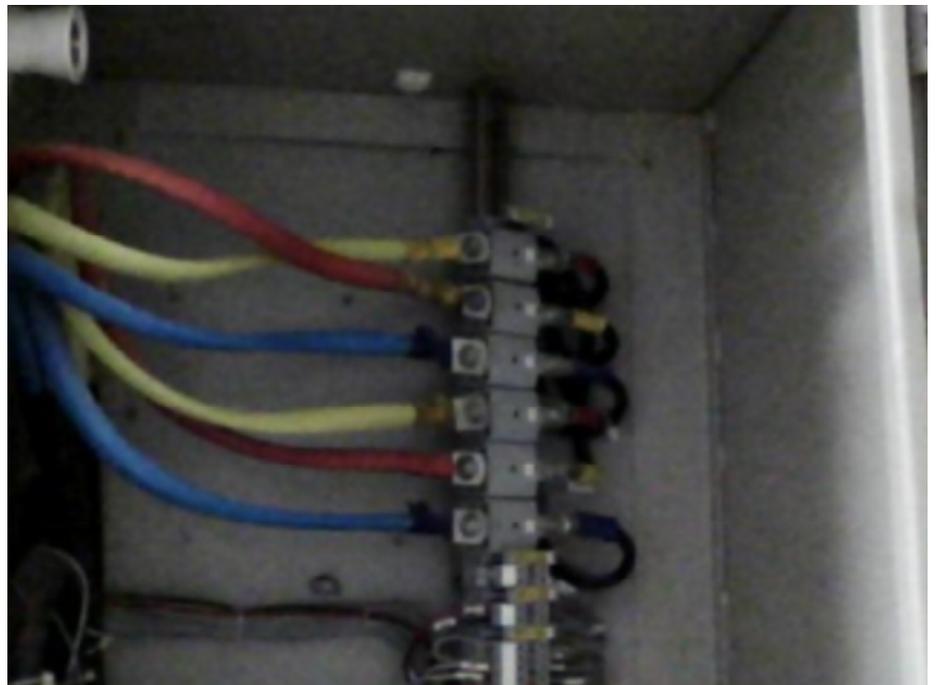
Location:- 2R Right Side Top Panel

Bx1	Max	31.6 °C
	Min	30.1 °C
	Average	30.9 °C

Note:- Maximum temp on 2R Right side Top Panel is 31.6°C, which is found normal.

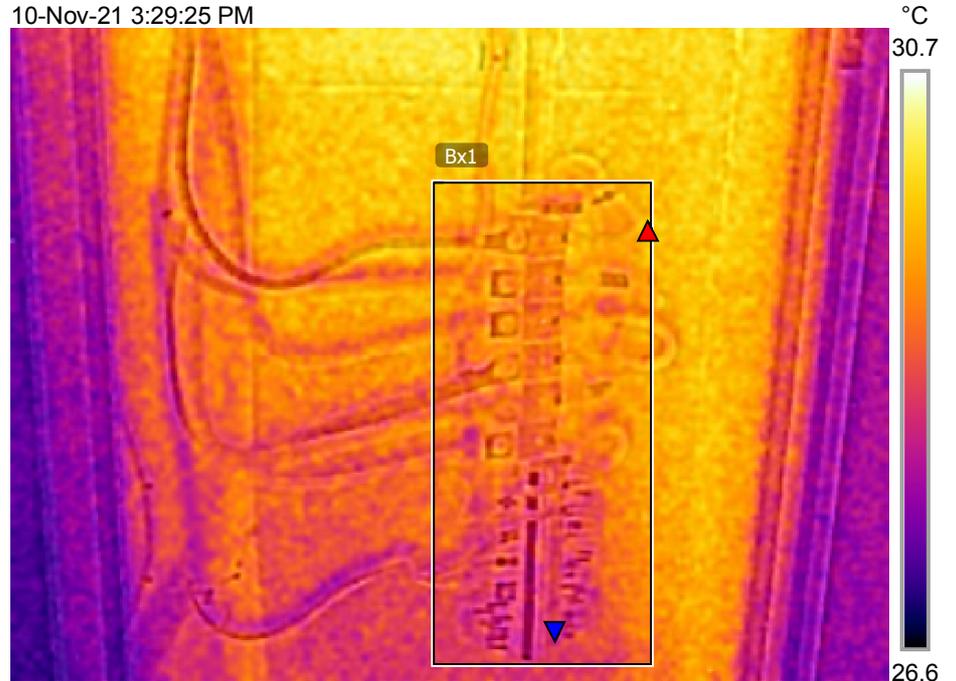
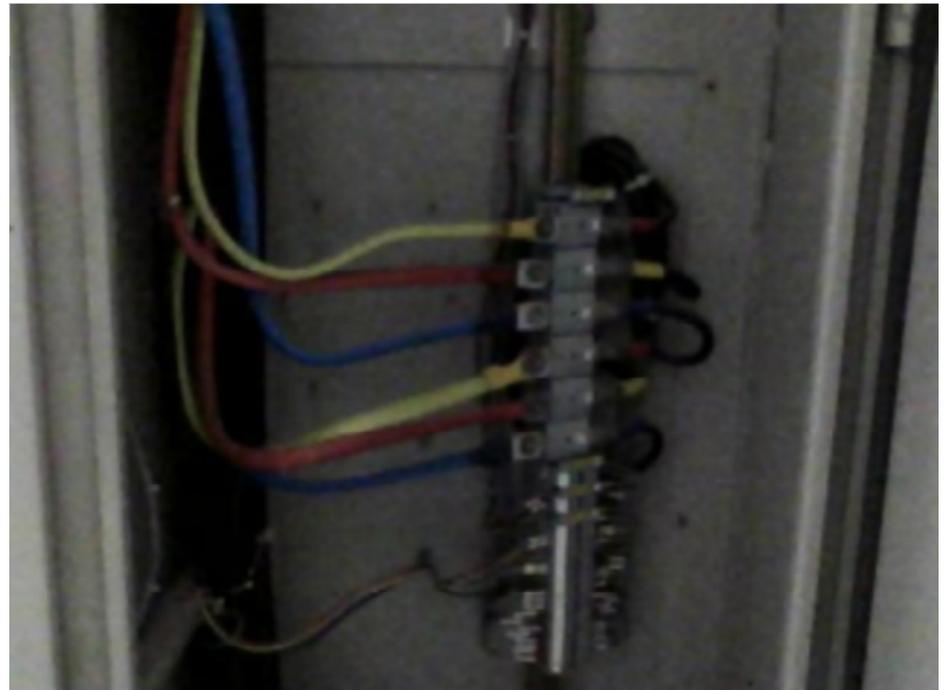
Location:- 2R Right Side Bottom Panel

Bx1	Max	29.7 °C
	Min	28.3 °C
	Average	29.0 °C

Note:- Maximum temp on 2R Right side Bottom Panel is 29.7°C, which is found normal.

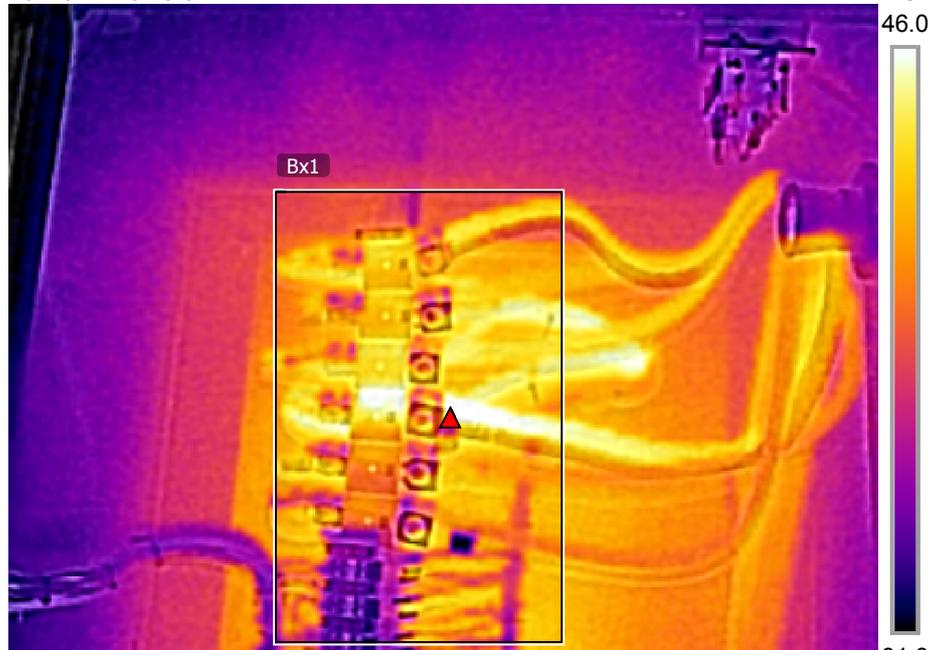
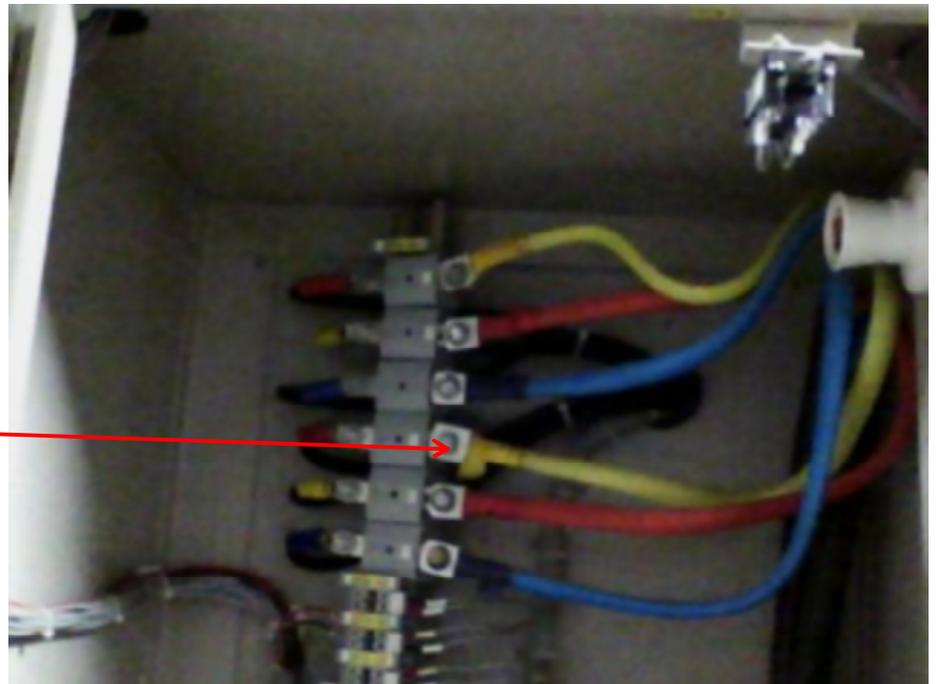
Location:-2R Left Side Top Panel

Bx1	Max	48.5 °C
-----	-----	---------

Note:- Maximum temp on 2R Left side Top Panel is 48.6°C, which is found above normal so please check the tightness.

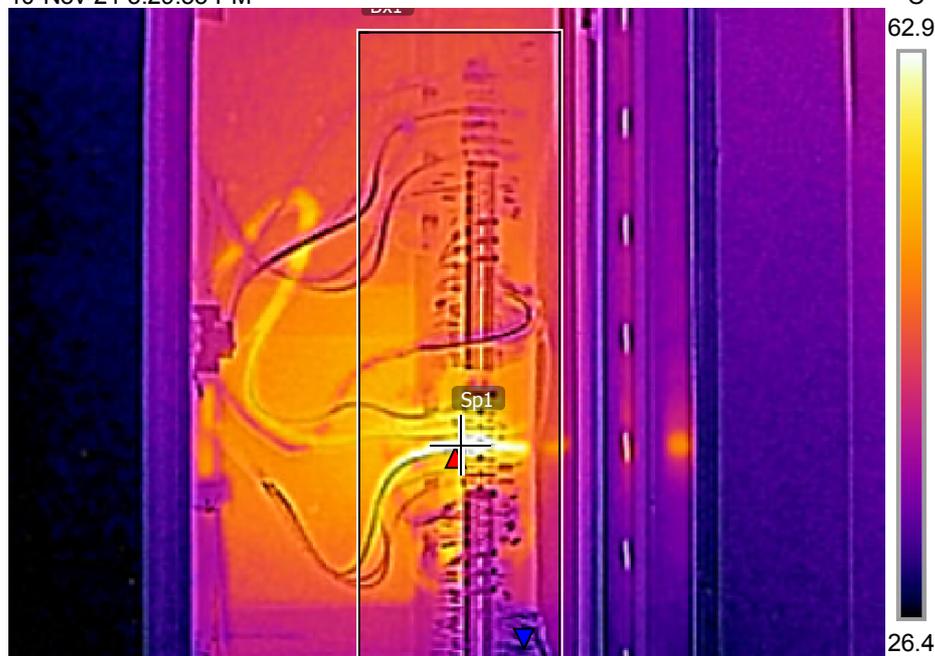
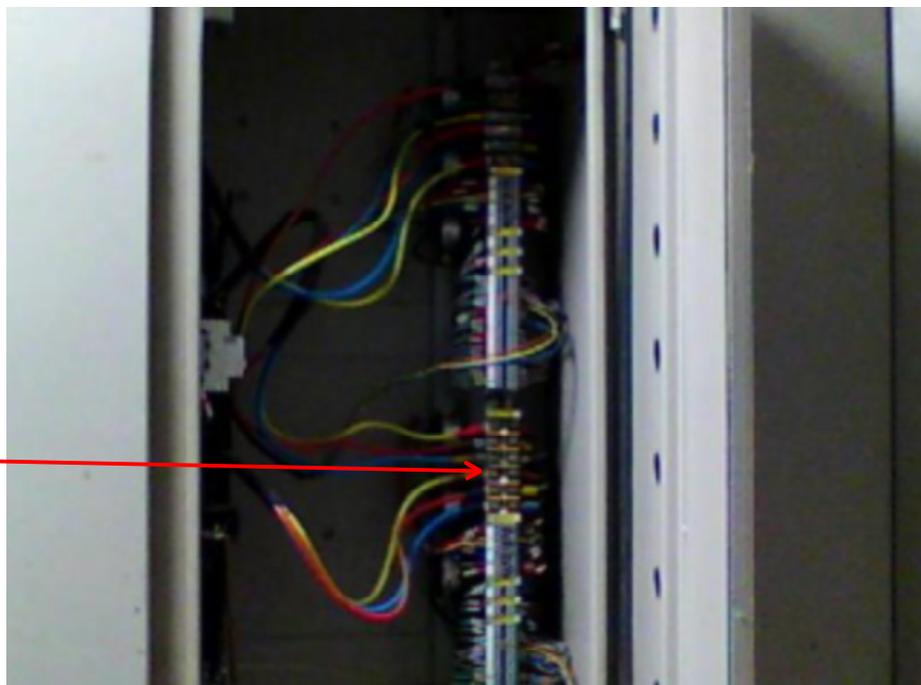
Location:- 3R Right Side Panel

Bx1	Max	98.7 °C
	Min	28.0 °C
	Average	35.2 °C
Sp1		89.4 °C

Note:- Maximum temp on 3R Right side Panel is 98.6°C, which is found in High Alarm Zone. So please check tightness of nut bolts, crimping of lugs and take necessary actions asap.

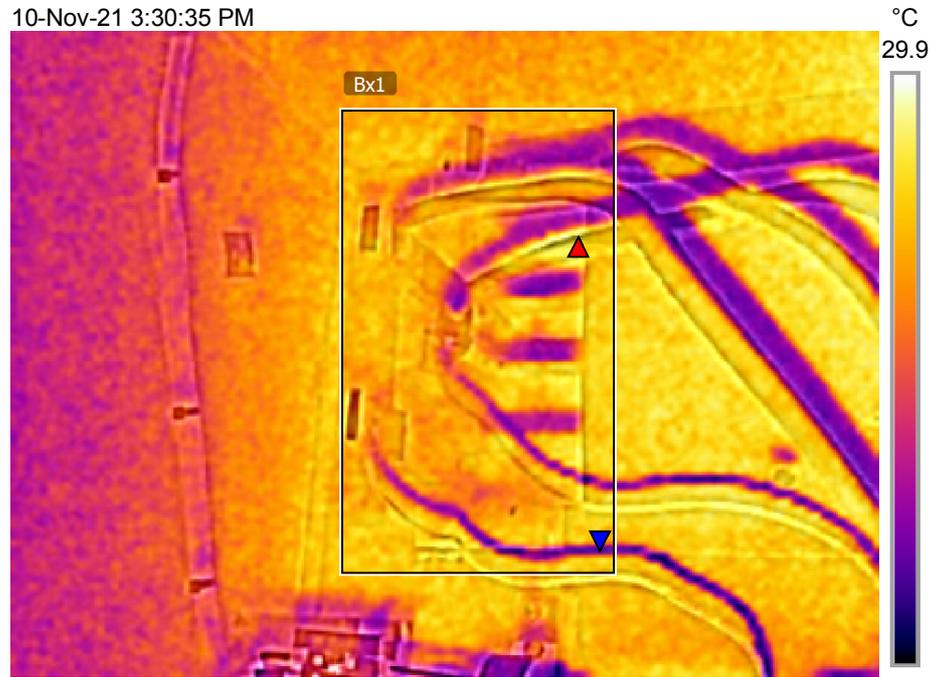
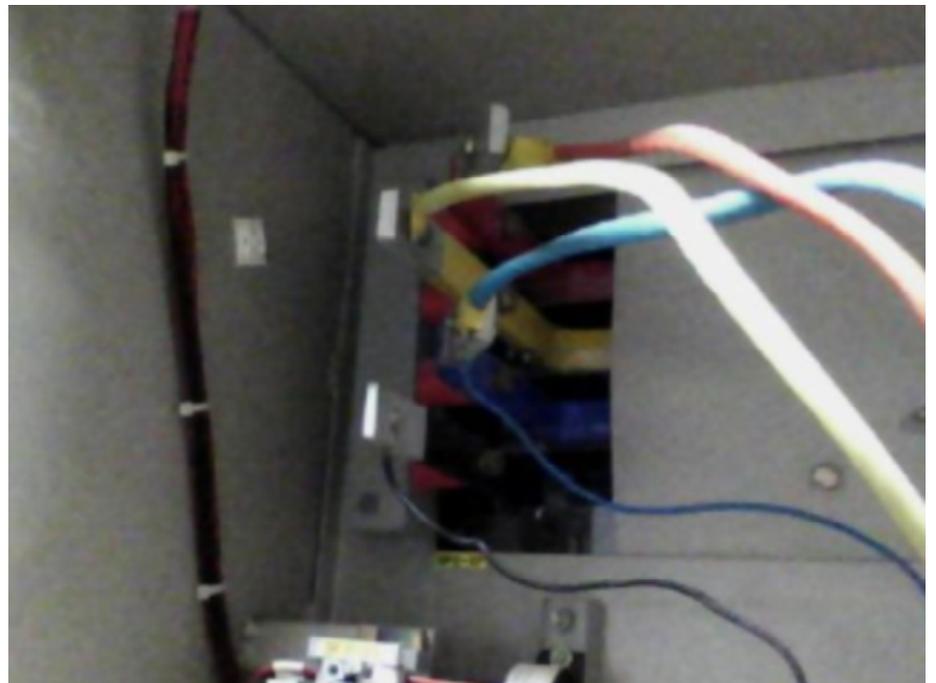
Location:- 3R Right Side Panel

Bx1	Max	29.4 °C
	Min	26.3 °C
	Average	28.5 °C

Note:- Maximum temp on 3R Right side Panel is 29.4°C, which is found normal.

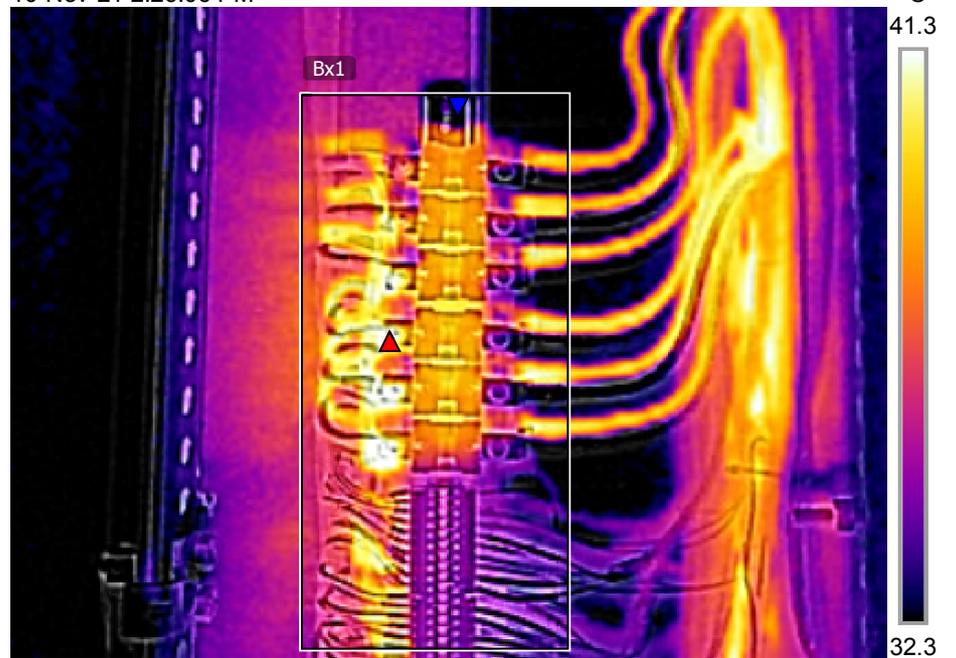
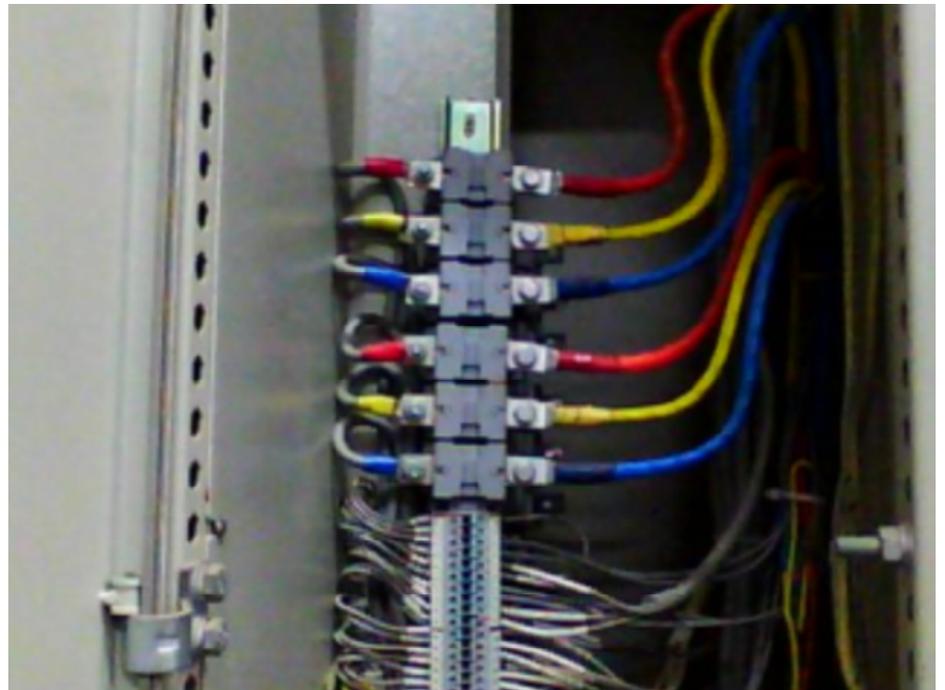
Unit:- Bromine MCC
Location:- 9F Top Panel

Bx1	Max	41.7 °C
	Min	31.0 °C
	Average	35.7 °C

Note:- Maximum temp on 9F Top Panel is 41.7°C, which is found normal.

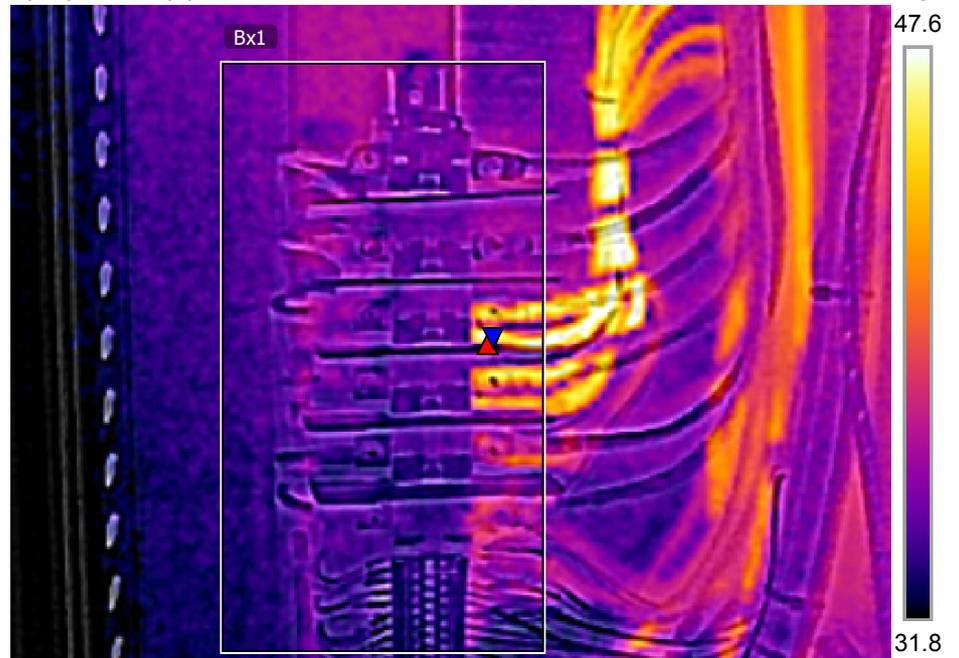
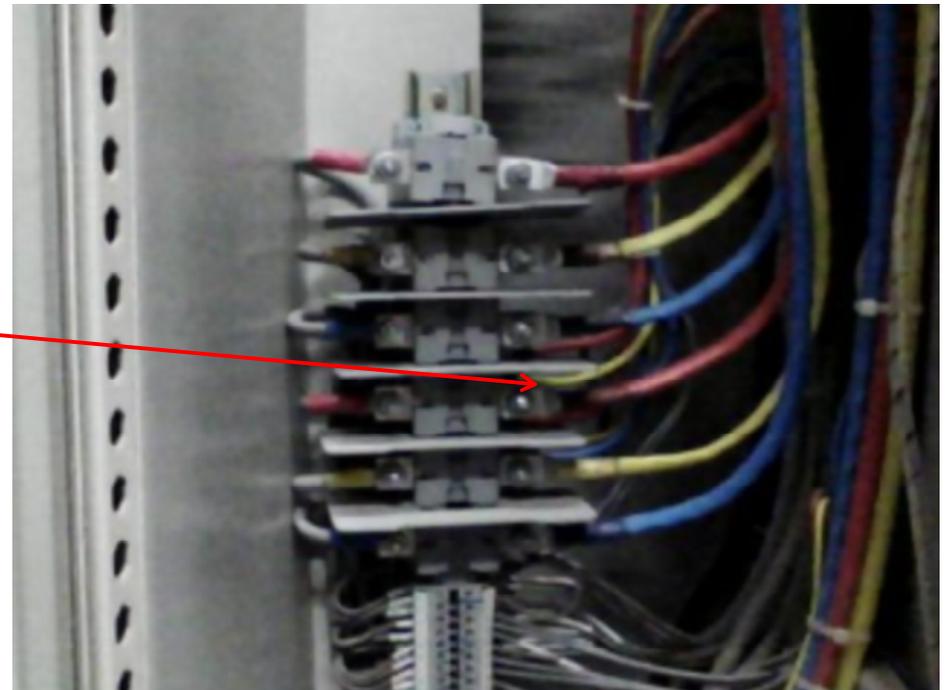
Location:- 9F Bottom Panel

Bx1	Max	53.1 °C
	Min	31.6 °C
	Average	32.8 °C

Note:- Maximum temp on 9F Bottom Panel is 53.1°C, which is found in Keep Watching Zone and take necessary action if required.

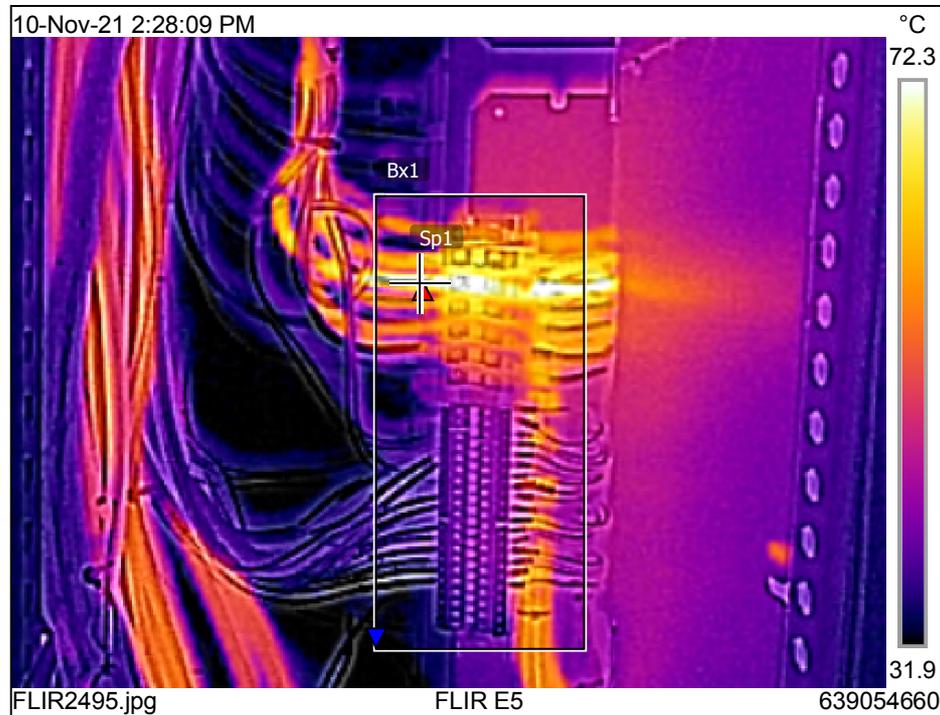
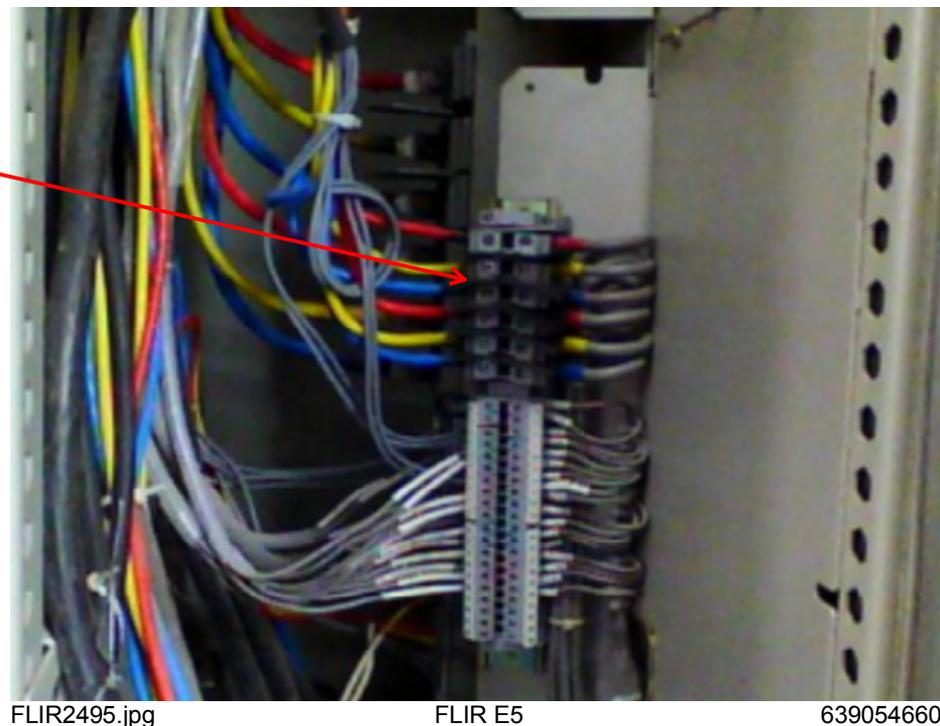
Location:- 9R Bottom Panel

Bx1	Max	89.1 °C
	Min	31.5 °C
	Average	39.7 °C
Sp1		80.3 °C

Note:- Maximum temp on 9R Bottom Panel is 89.1°C, which is found in High Alarm Zone. So please check tightness of nut bolts, crimping of lugs and take necessary actions asap.

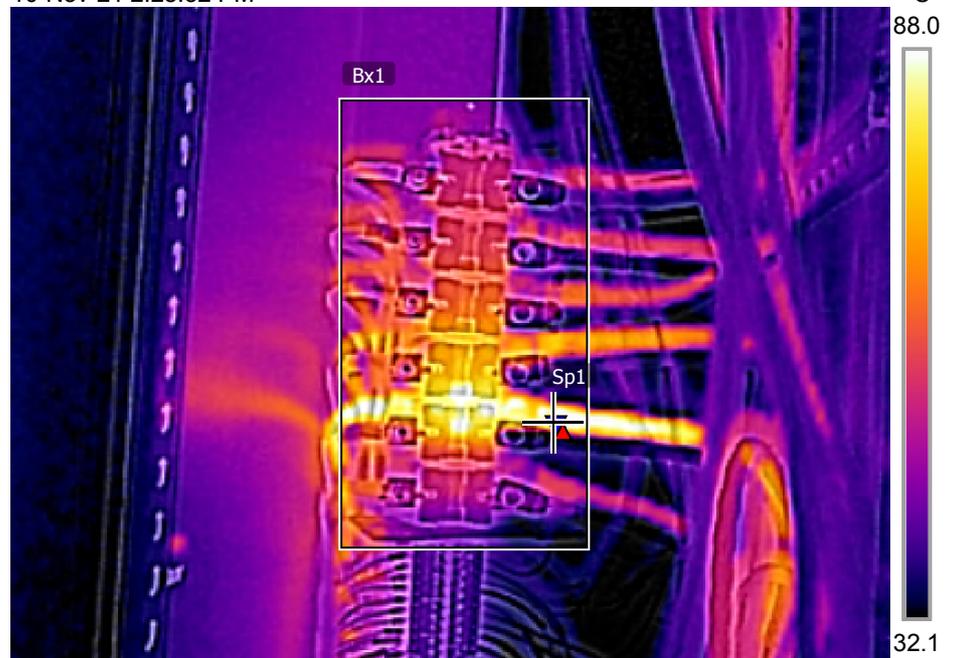
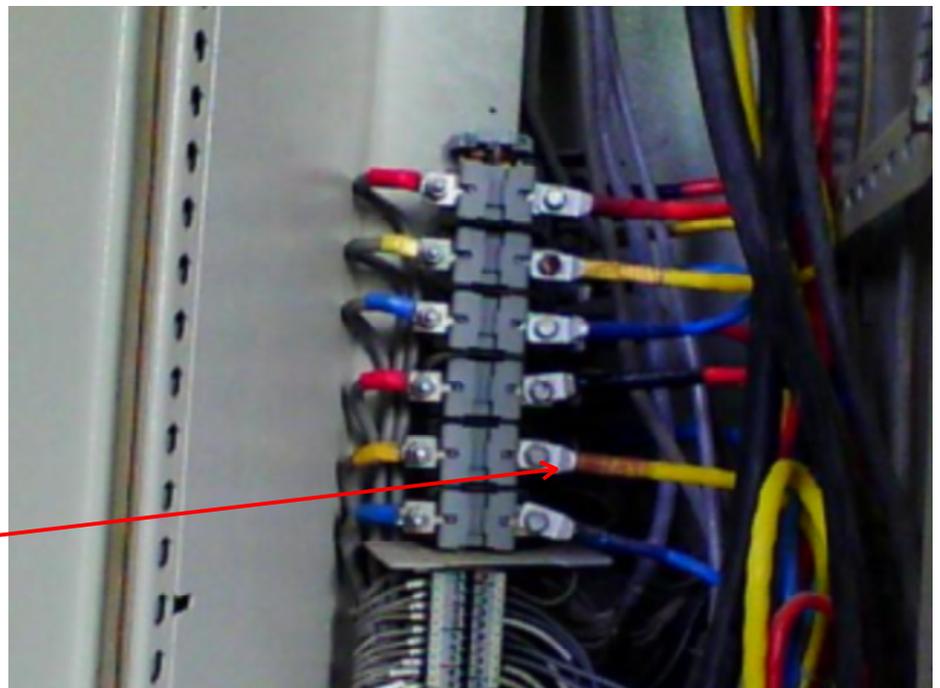
Unit:- Bromine MCC
Location:- 8R Bottom Panel

Bx1	Max	113.9 °C
	Min	29.1 °C
	Average	43.3 °C
Sp1		96.2 °C

Note:- Maximum temp on 8R Bottom Panel is 113.9°C, which is found in High Alarm Zone. So please check tightness of nut bolts, crimping of lugs and take necessary actions asap.

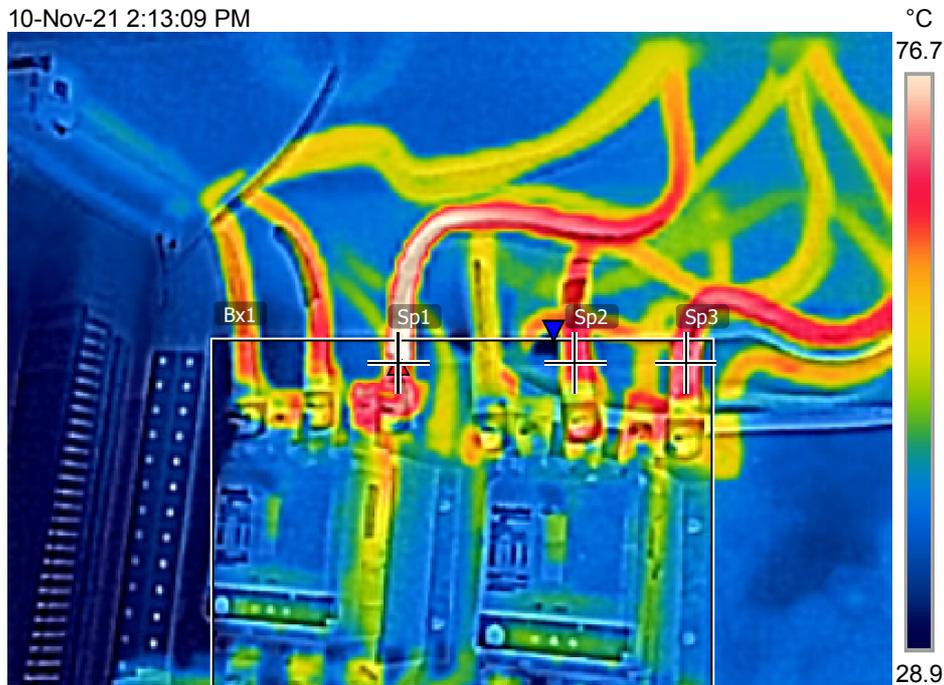
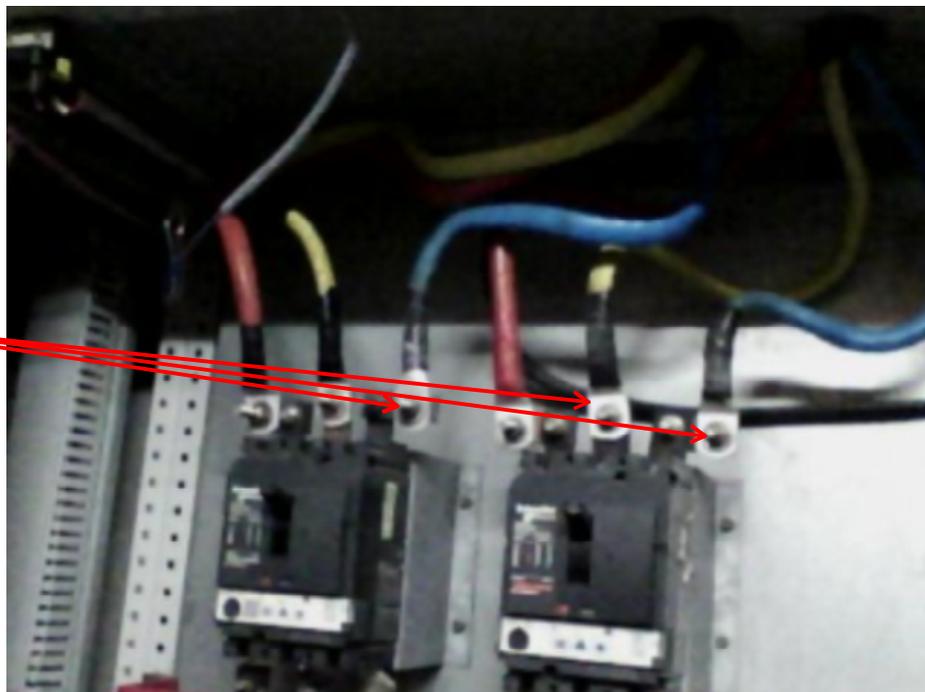
Location:- High Pressure Pump A

Bx1	Max	85.6 °C
	Min	27.8 °C
	Average	38.1 °C
Sp1		66.3 °C
Sp2		60.3 °C
Sp3		64.5 °C

Note:- Maximum temp on High Pressure Pump A is 85.6°C,66.3°C, 60.3°C, 64.5°C which is found in Keep Watching Zone. Tight the Lugs and if required take necessary action.
