Company SBI GENERAL INSURANCE

Customer SATYESH BRINE CHEM PVT LTD.

Measuring Date:- 10/11/2021

Task:- This examination was carried out according to EN 13187 using a thermal imager.

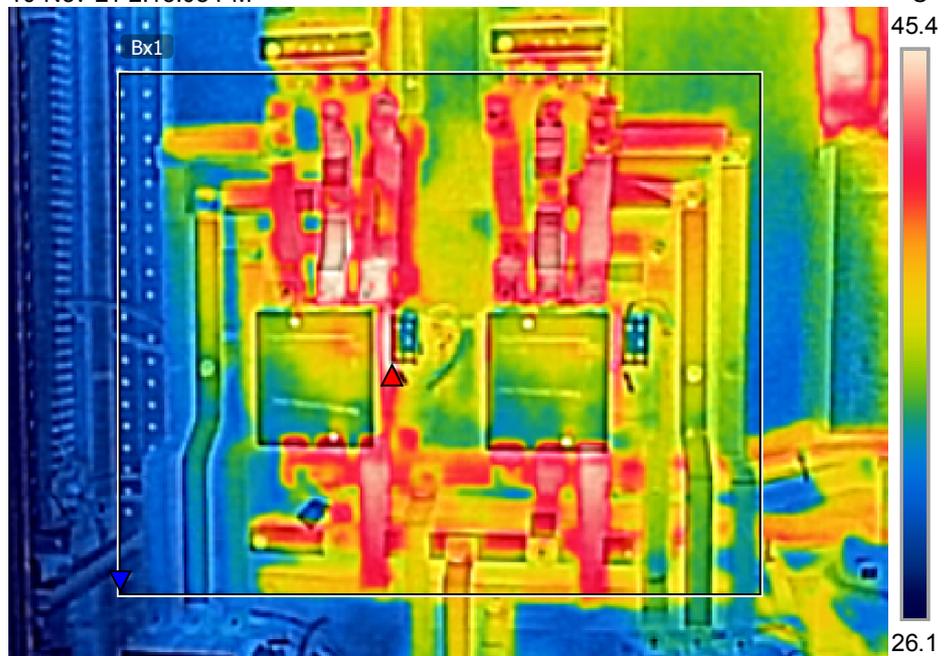
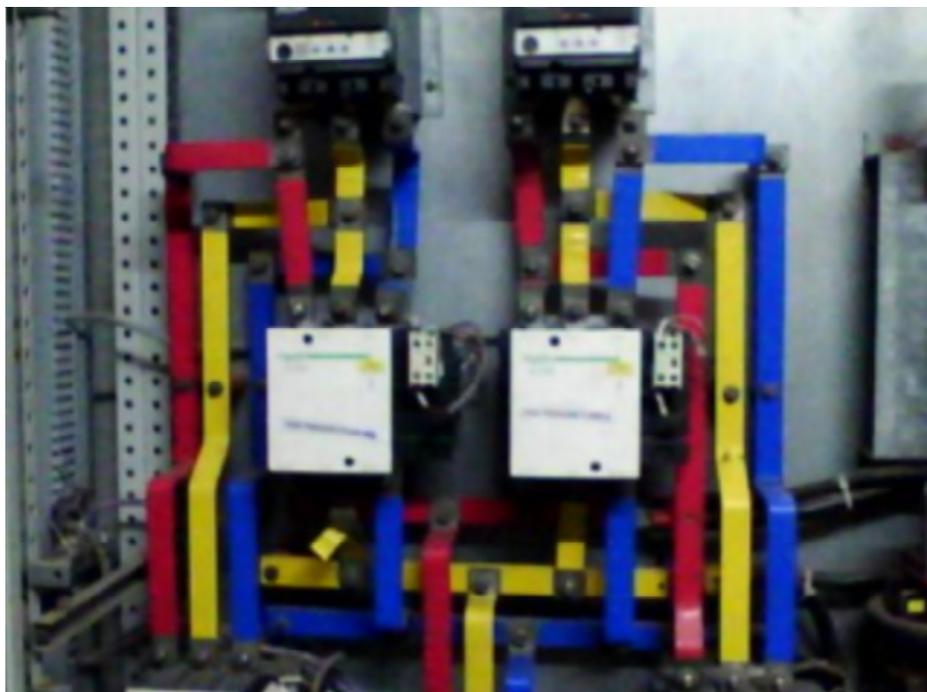
Location:- High Pressure Pump B

Bx1	Max	46.4 °C
	Min	28.1 °C
	Average	35.0 °C

Note:- Maximum temp on High Pressure Pump B is 46.4°C, which is found normal.

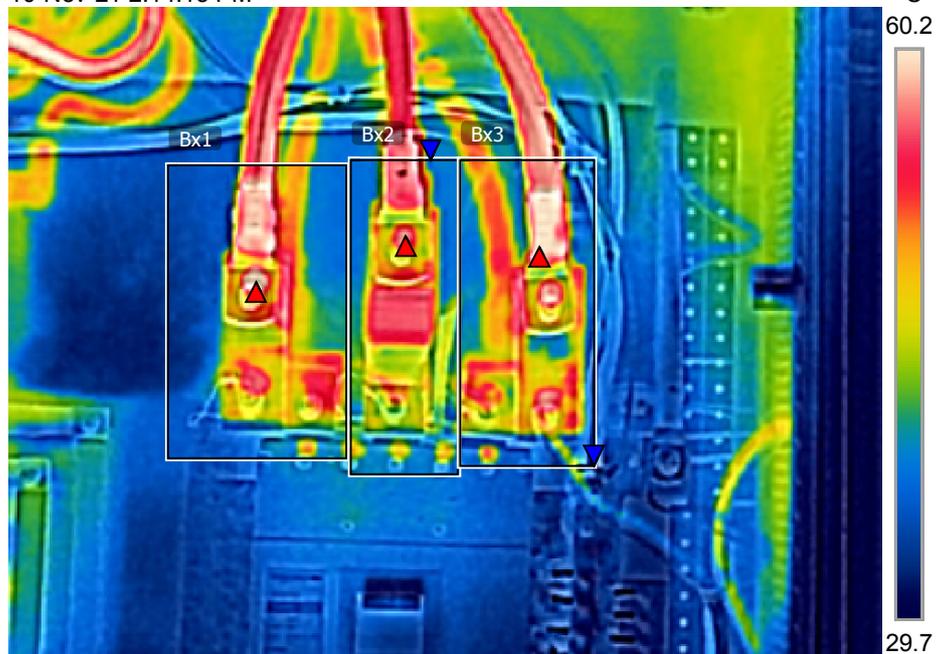
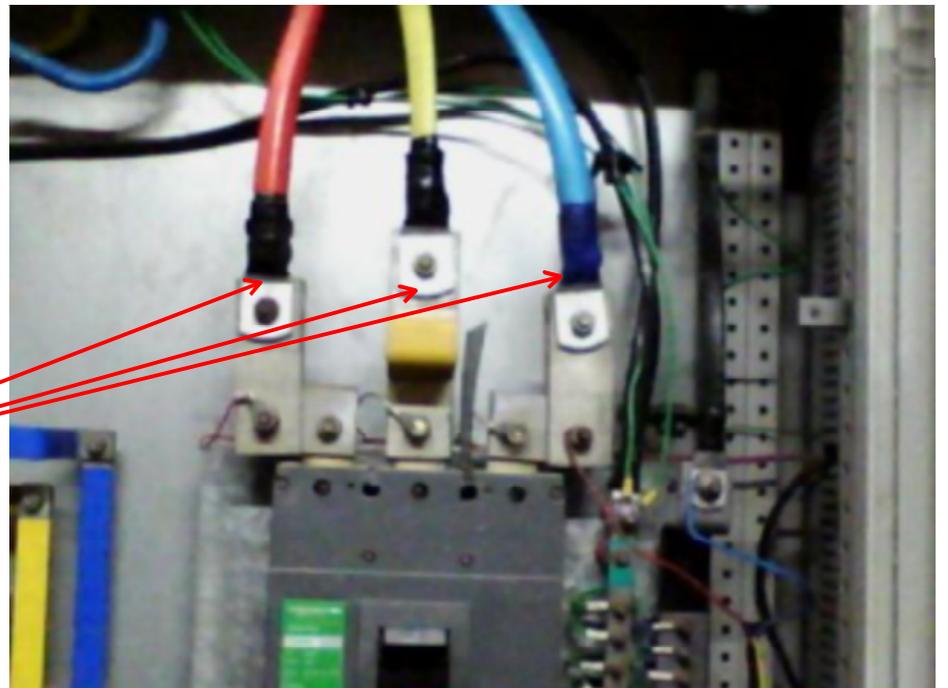
Unit:- Desalination Location:- Main Feeder

Bx1	Max	62.9 °C
Bx2	Max	57.0 °C
	Min	33.4 °C
	Average	40.7 °C
Bx3	Max	61.7 °C
	Min	32.0 °C
	Average	41.7 °C

Note:- Maximum temp on Main Feeder is 62.9°C, 57.0°C, 61.7°C, which is found in Keep Watching Zone take necessary action if required.

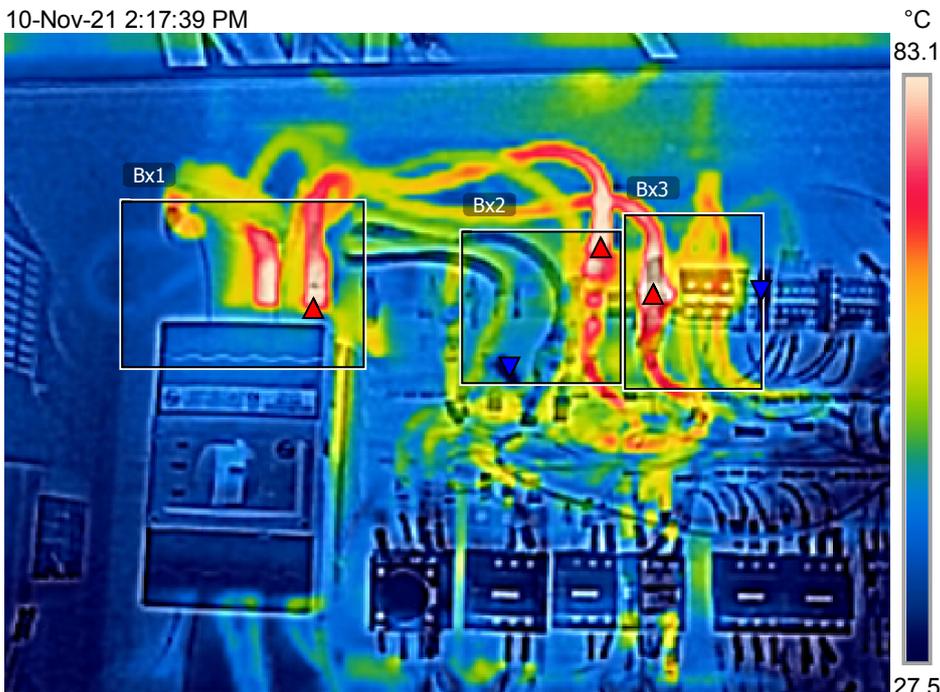
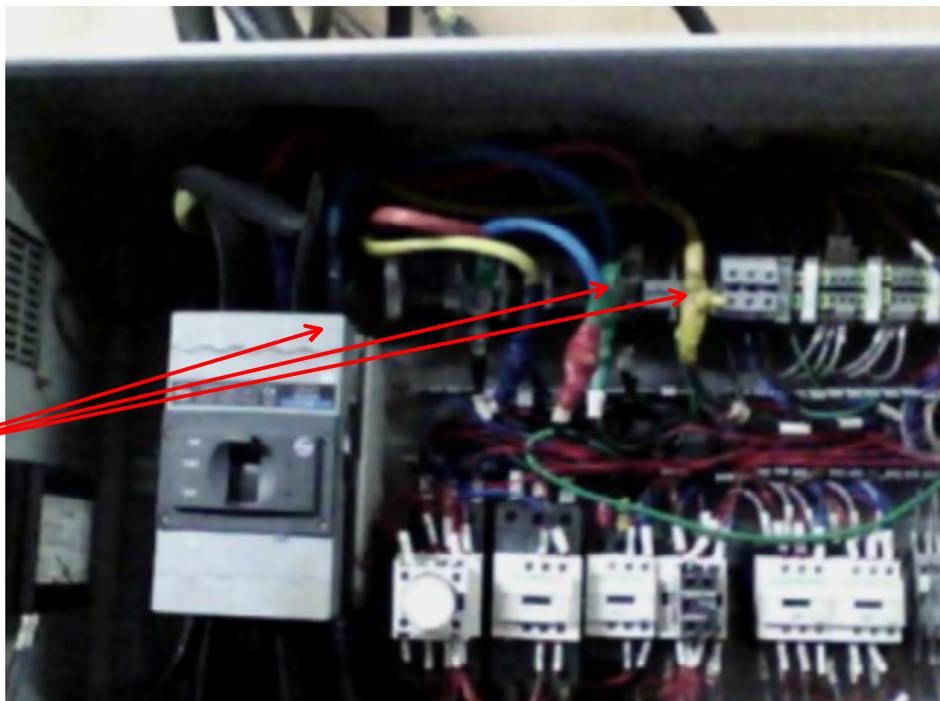
**Unit:- Desalination
Location:- BWRO Panel**

Bx1	Max	94.3 °C
Bx2	Max	118.0 °C
	Min	24.6 °C
	Average	39.1 °C
Bx3	Max	92.9 °C
	Min	28.5 °C
	Average	43.5 °C

Note:- Maximum temp on BWRO Panel is 94.3°C, 118.0°C, 92.9°C, which is found in High Alarm Zone. Tight the Lugs, Change the wire and take necessary action if required.

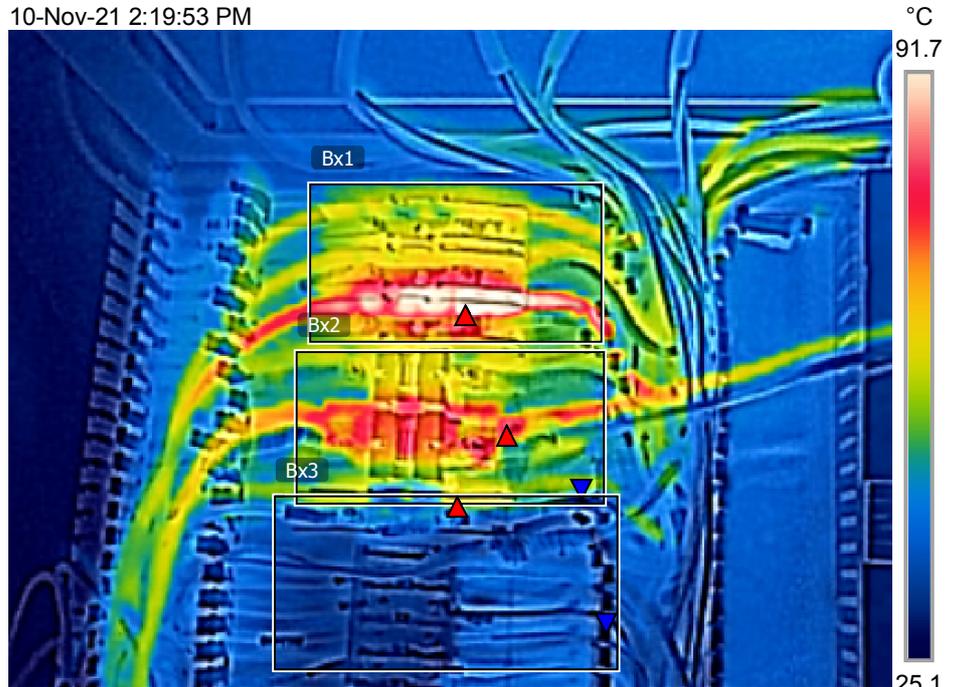
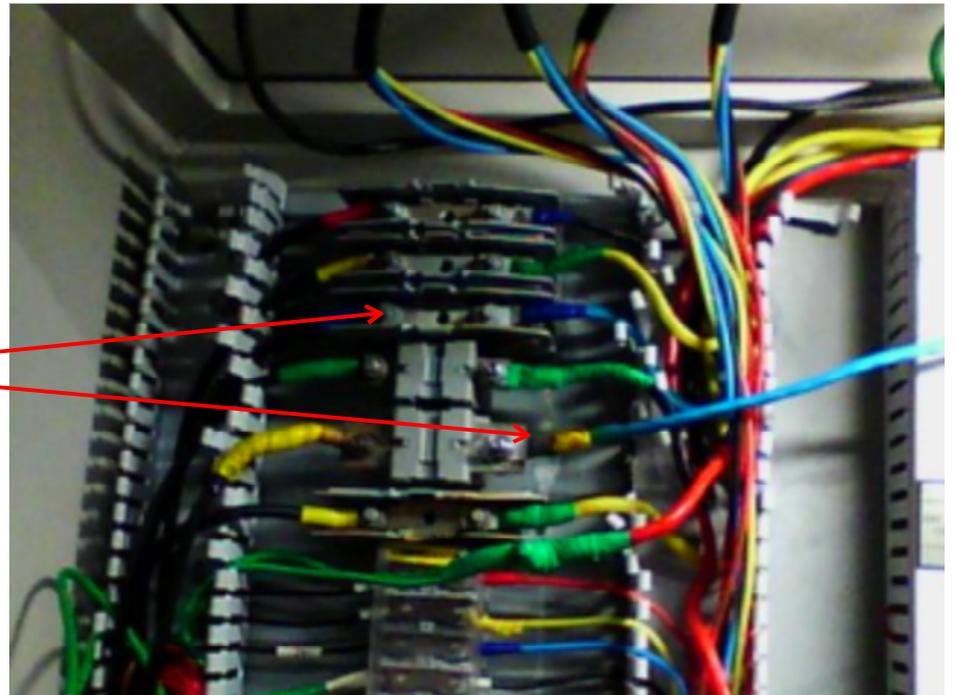
Location:- DAF Panel

Bx1	Max	122.5 °C
Bx2	Max	74.7 °C
	Min	27.9 °C
	Average	42.2 °C
Bx3	Max	43.4 °C
	Min	26.2 °C
	Average	29.4 °C

Note:- Maximum temp on DAF Panel is 122.5°C,74.7°C, which is found in High Alarm Zone. Tight the Lugs, change the cable and take necessary action if required.

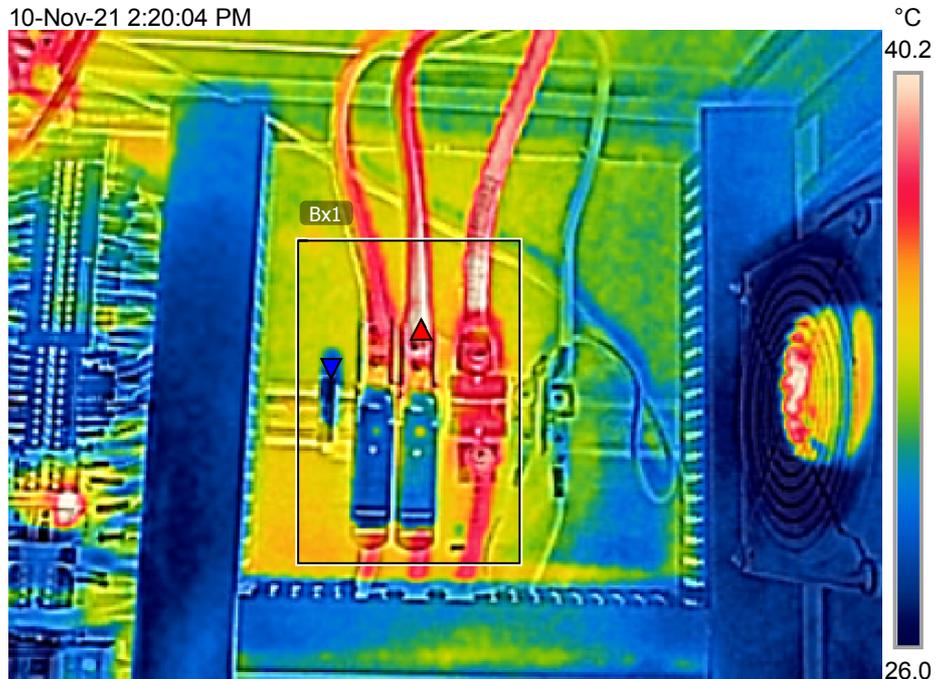
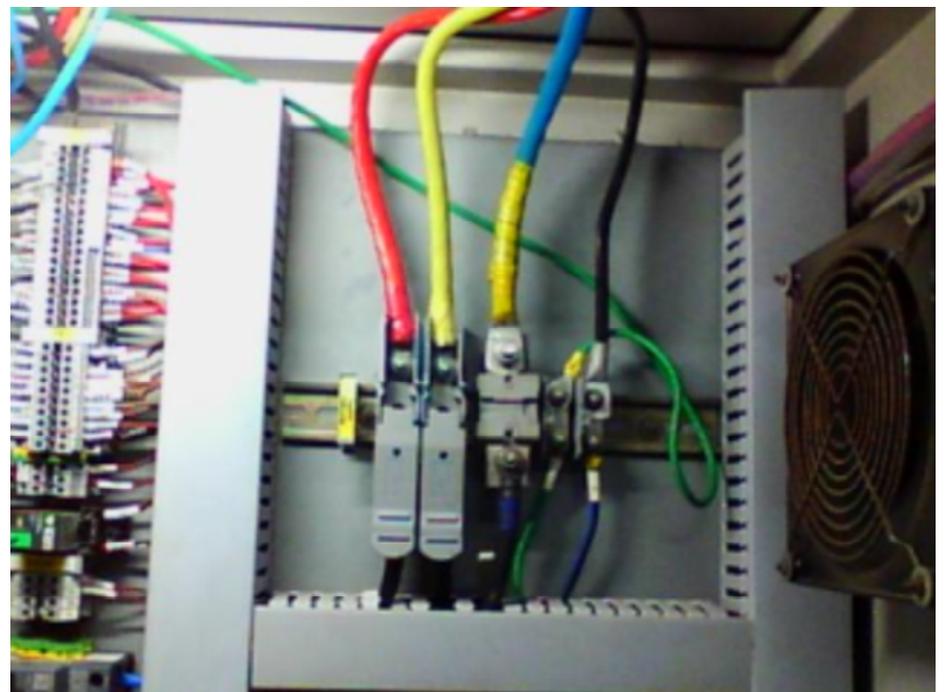
Unit:- Desalination
Location:- DAF Panel

Bx1	Max	42.7 °C
	Min	26.8 °C
	Average	31.7 °C

Note:- Maximum temp on DAF Panel is 42.7°C, which is found normal

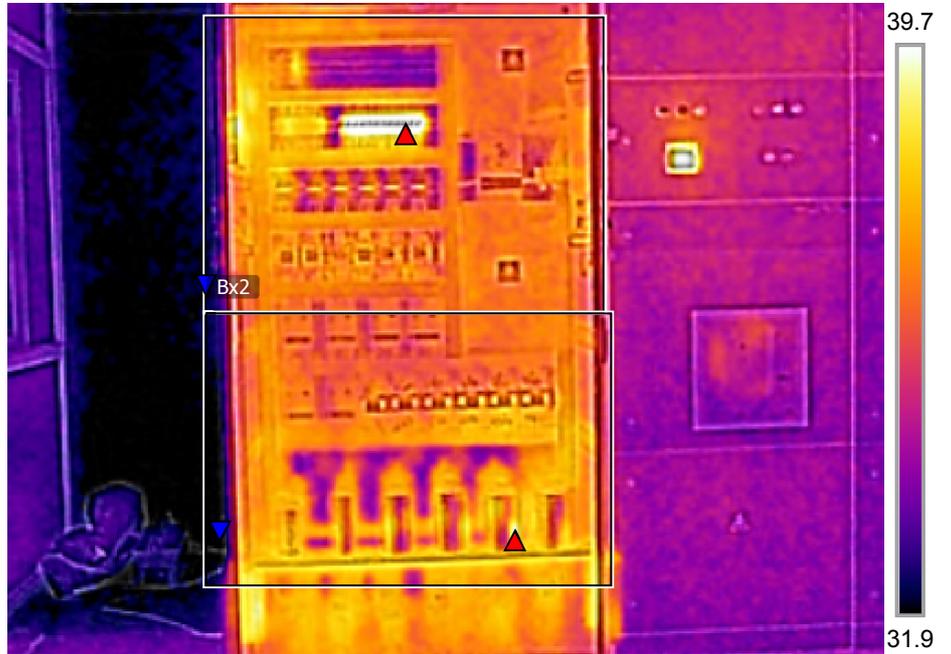
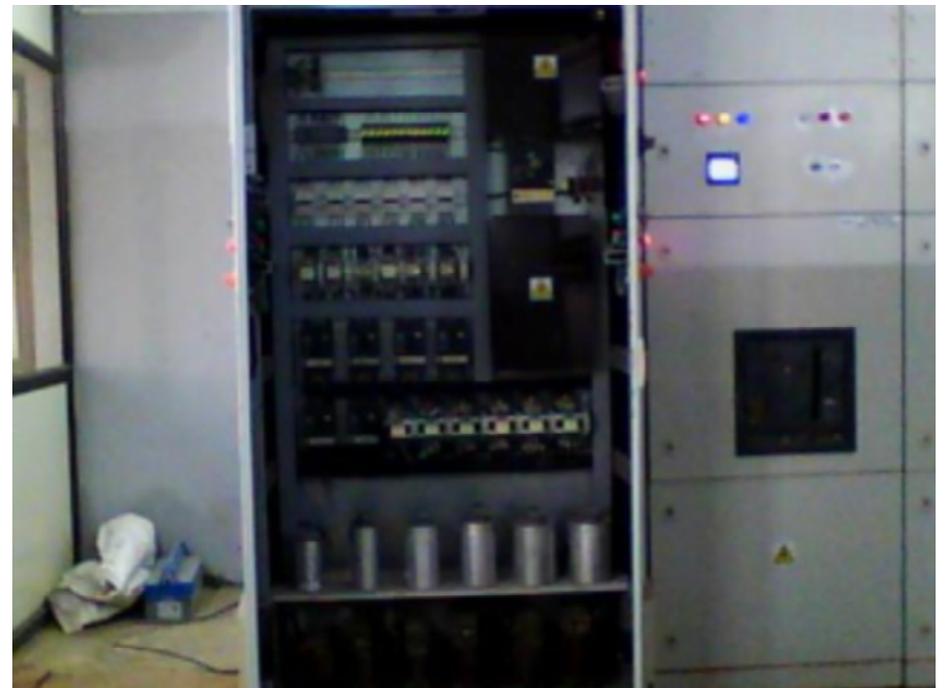
Location:- Front

Bx1	Max	44.7 °C
	Min	31.9 °C
	Average	34.8 °C
Bx2	Max	39.8 °C
	Min	31.3 °C
	Average	34.7 °C

Note:- Maximum temp on Washry Room MCC Front Panel is 44.7°C, which is found normal

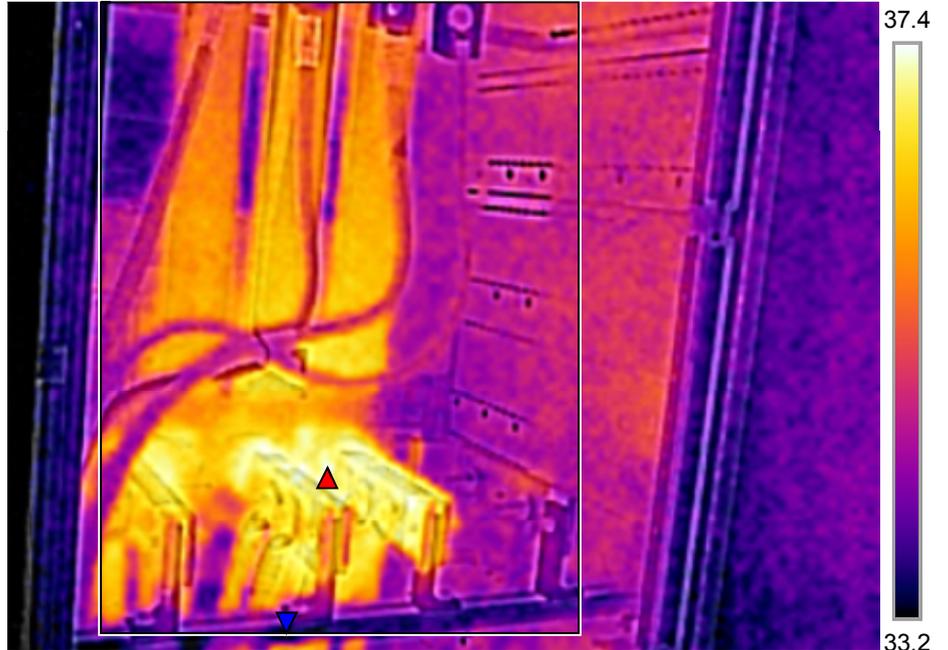
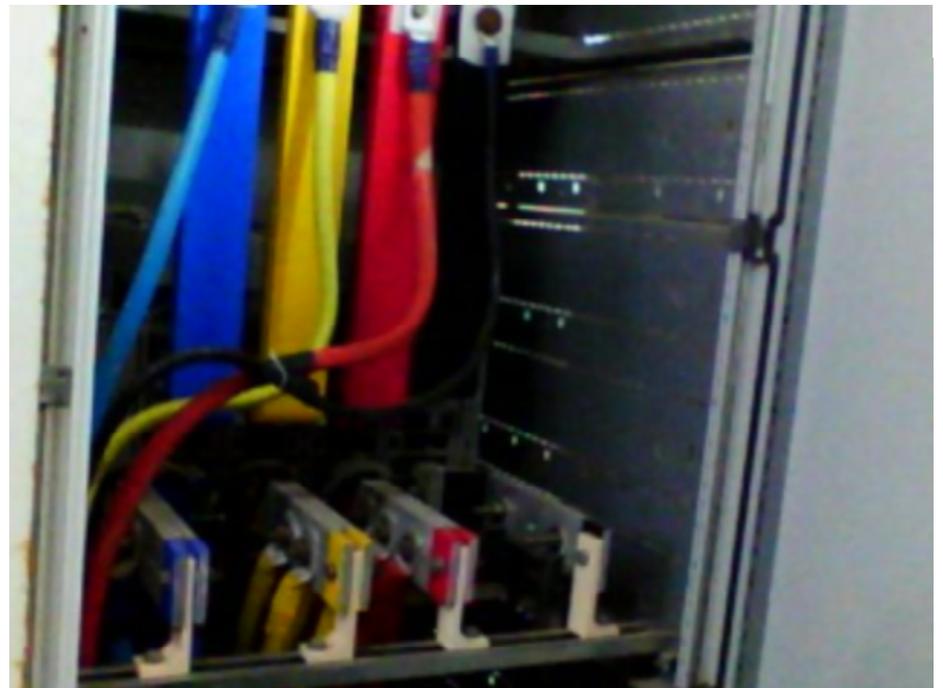
Unit:- Washry Room
Location:- Rear

Bx1	Max	37.3 °C
	Min	33.1 °C
	Average	34.9 °C

Note:- Maximum temp on Washry Room MCC Rear Panel is 37.3°C, which is found normal.

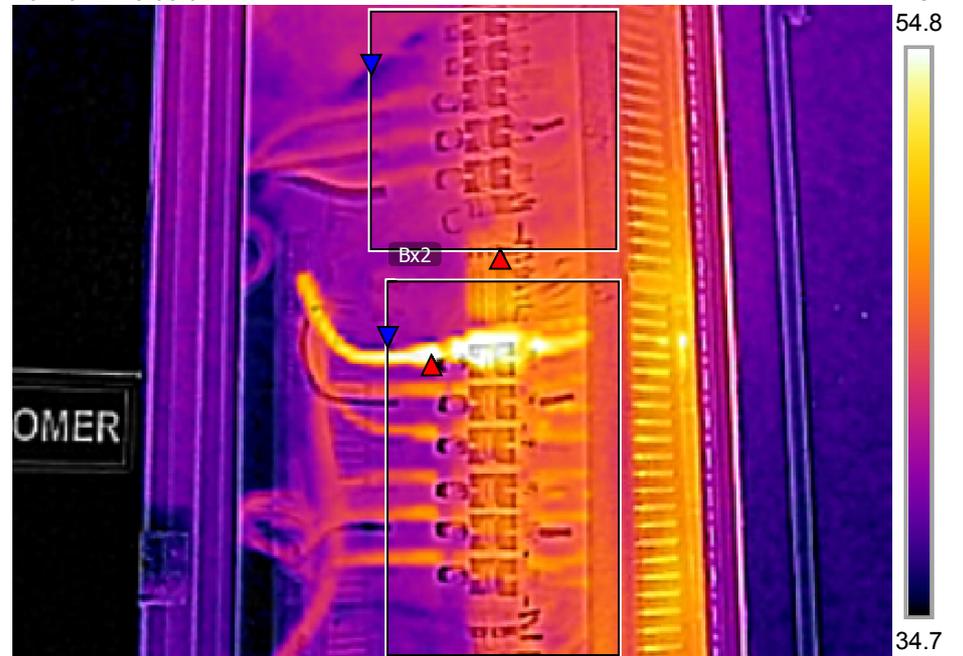
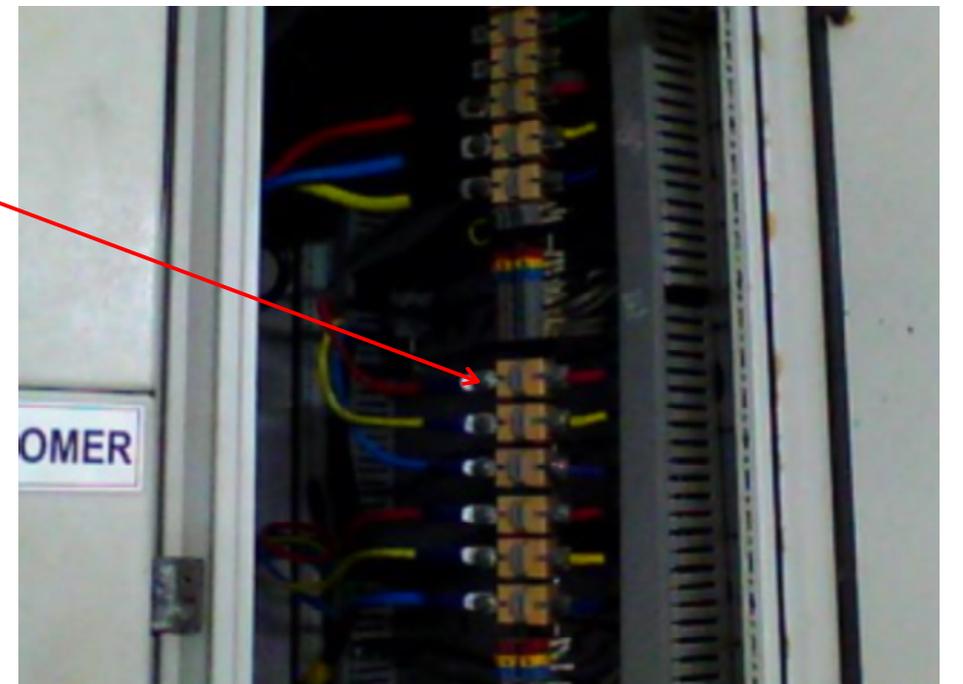
Location:- Cable Chamber Front

Bx1	Max	40.1 °C
	Min	35.9 °C
	Average	38.5 °C
Bx2	Max	70.7 °C
	Min	35.8 °C
	Average	39.9 °C

Note:- Maximum temp on Washry Room MCC Cable chamber is 70.7°C, which is found in Alarm zone so change the lug or cable.

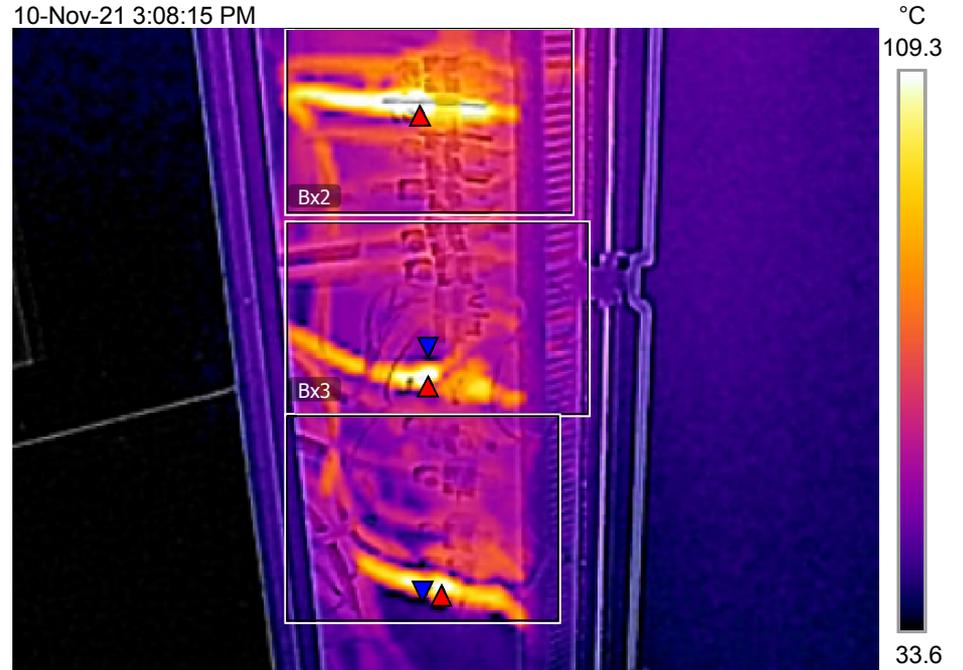
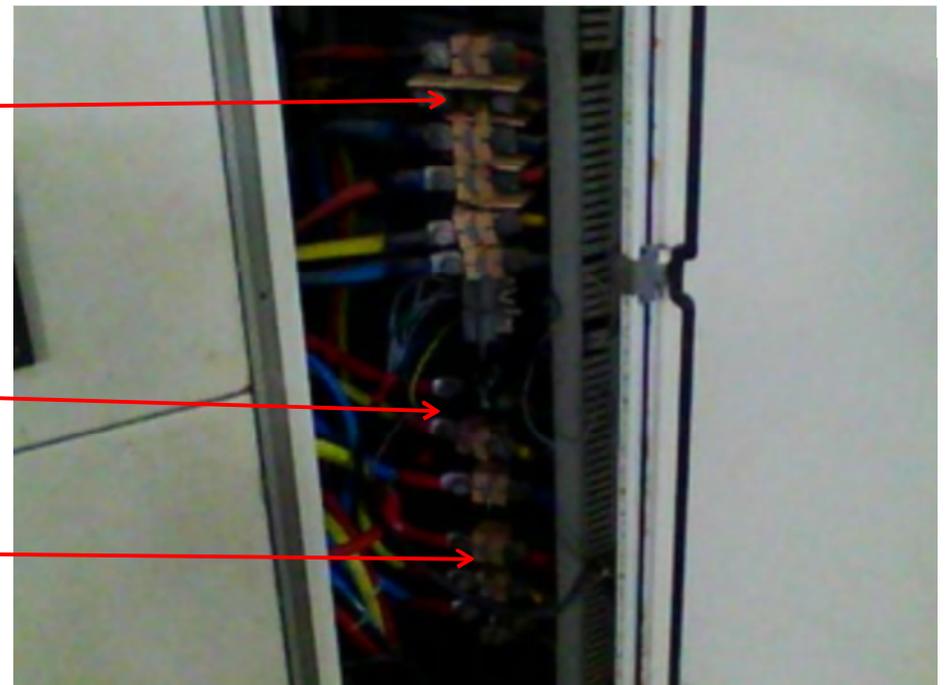
Location:- Cable Chamber Front

Bx1	Max	208.5 °C
Bx2	Max	136.1 °C
	Min	32.6 °C
	Average	41.3 °C
Bx3	Max	125.9 °C
	Min	31.2 °C
	Average	40.2 °C

Note:- Maximum temp on Washry Room MCC Cable chamber is 208.5°C, 136.1°C, 125.9°C which is found in High Alarm zone so change the lug or cable or take necessary action if required.
