## Sample Report

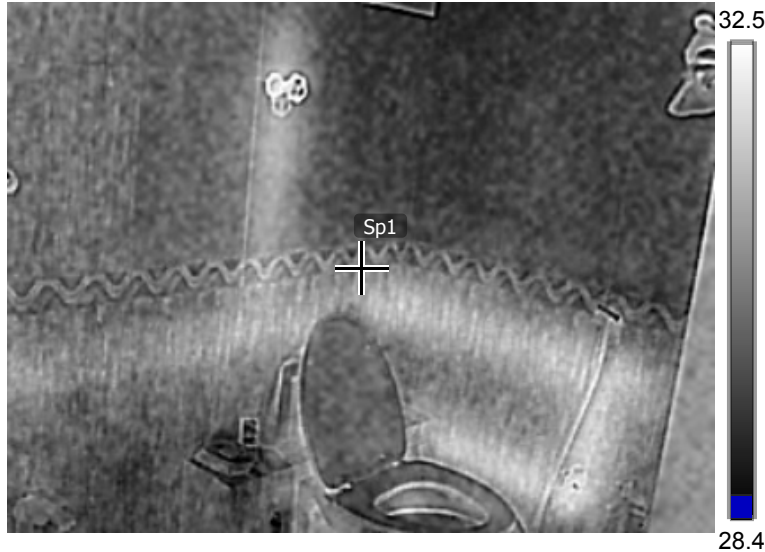
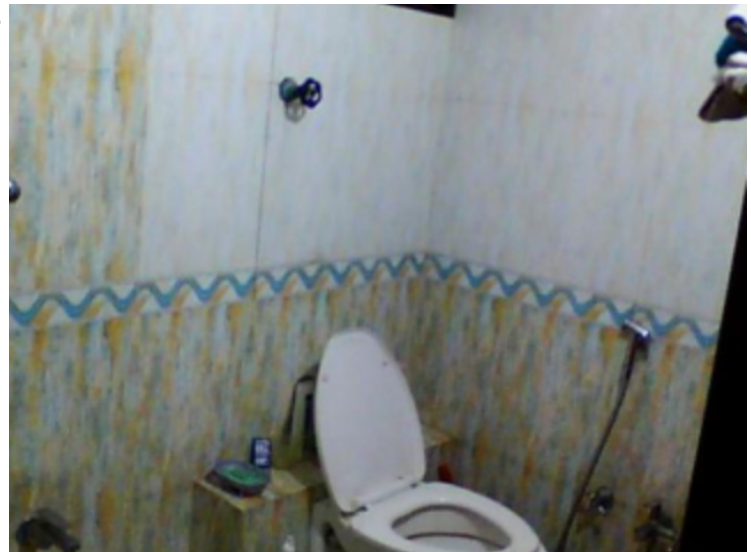
FLIR0016.jpg

**Pipe connection upto certain depth and leakage among them can be seen easily.**

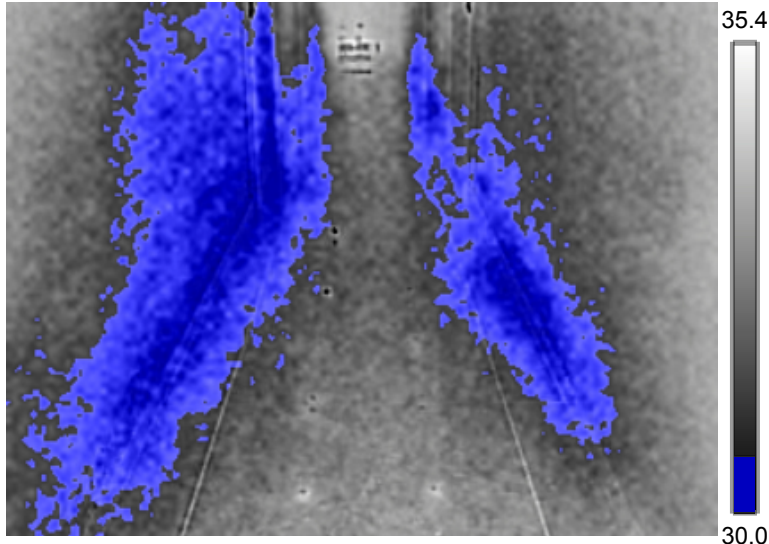
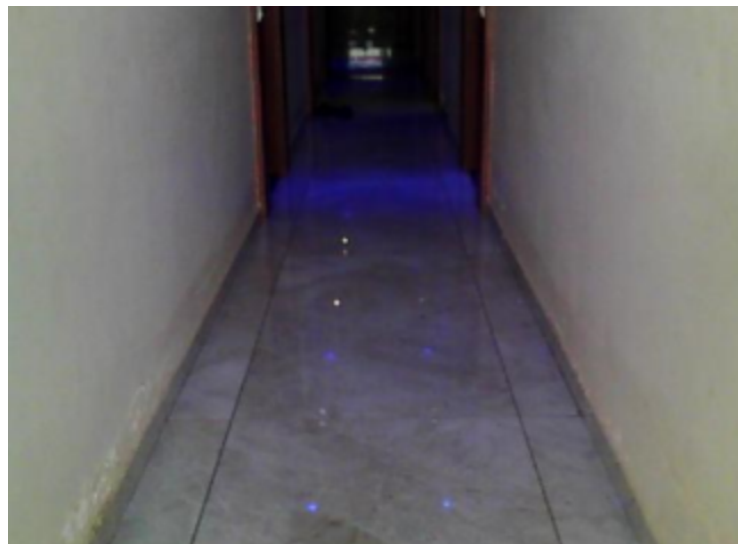
FLIR1282.jpg

**Flooding - water wicking up a wall and damaging down wall studs.**

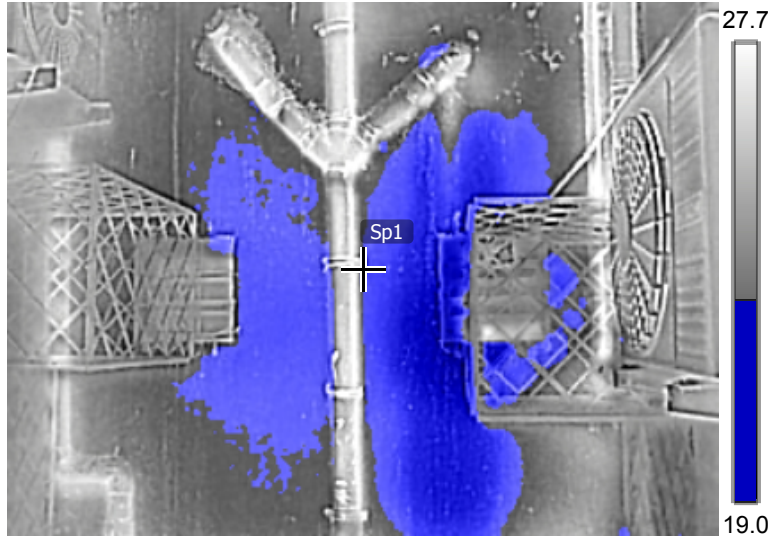
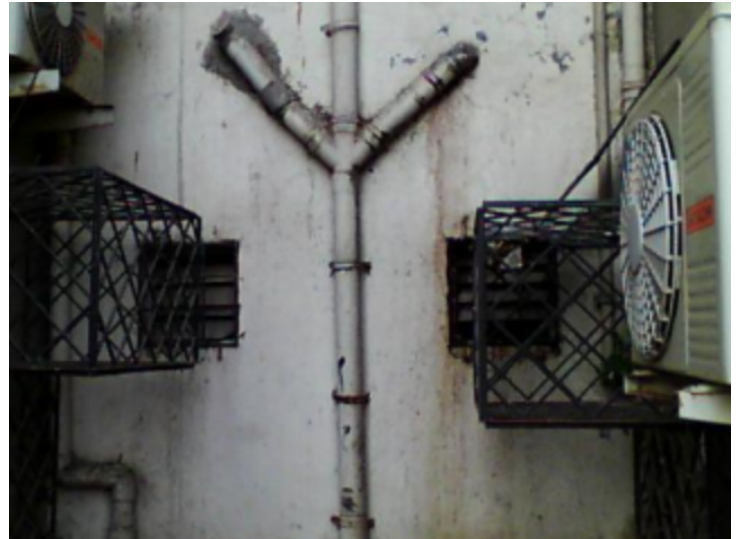
**Leakage due to waste drainage pipe.**

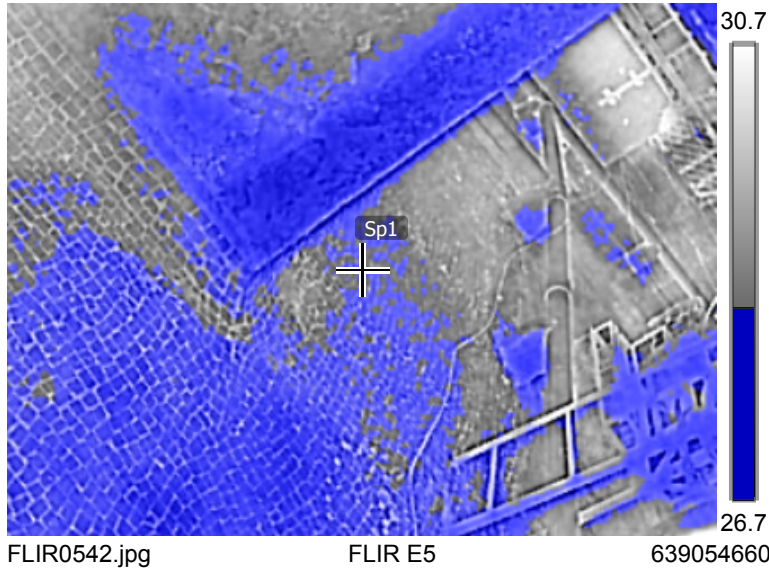
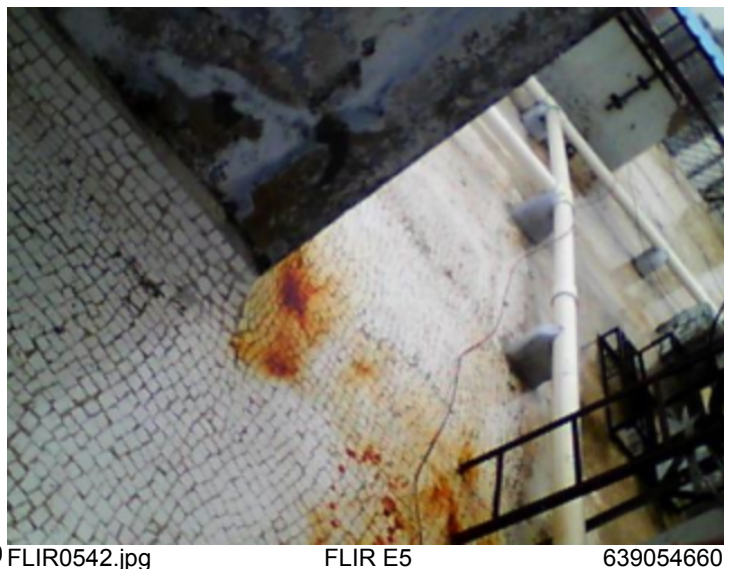
**Terrace:- Water leakage due to loose joints of tiles and water tank leakage.**

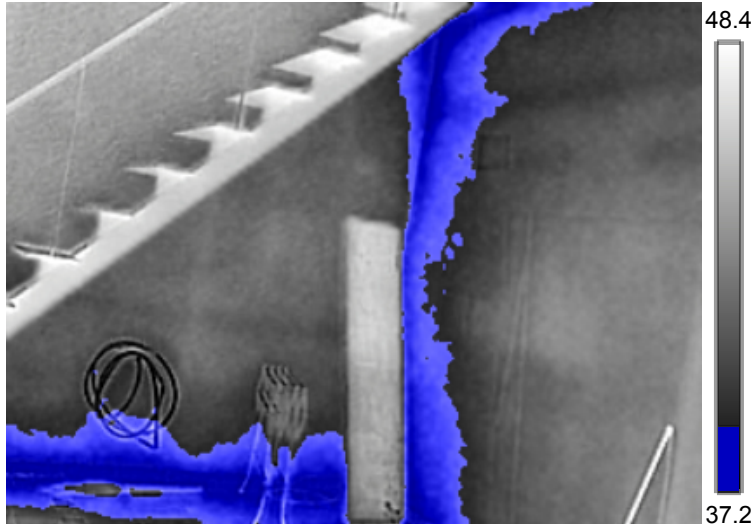
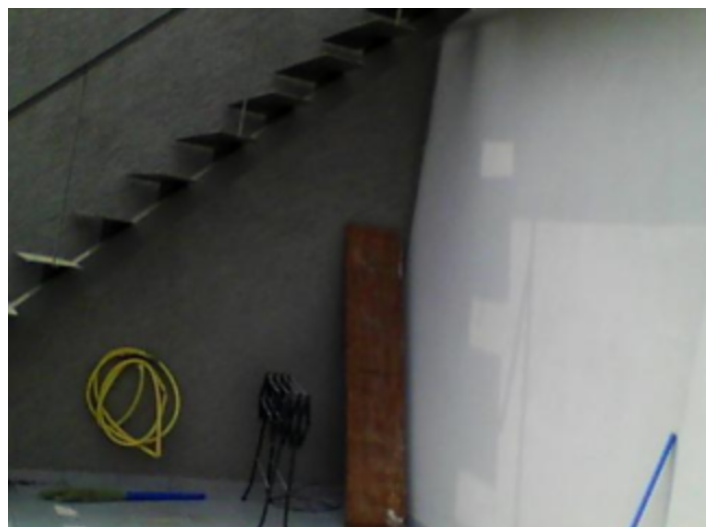
FLIR1209.jpg

**Walls - top-down triangular shape formed as water spreads downwards.**

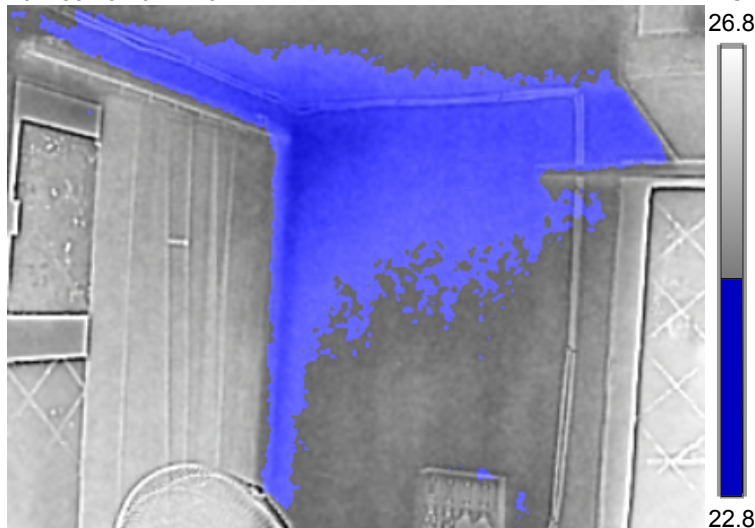
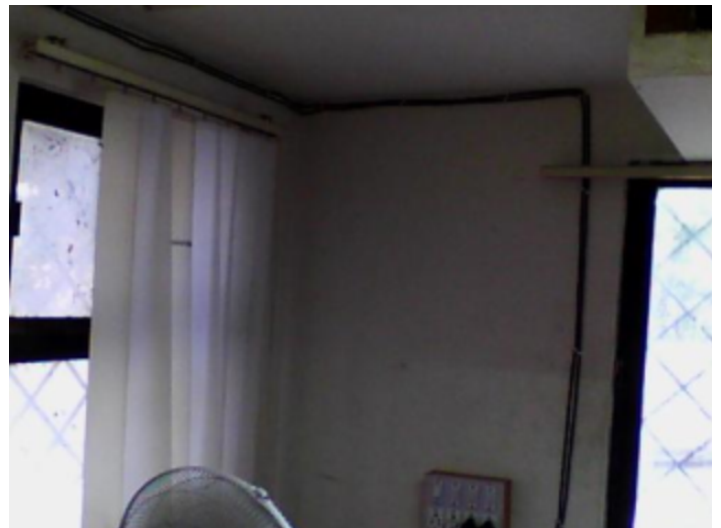
FLIR0046.jpg

**Ceiling - amorphous, unstructured shape with areas of wet, damp, and moist material spreading outwards with different temperatures.**

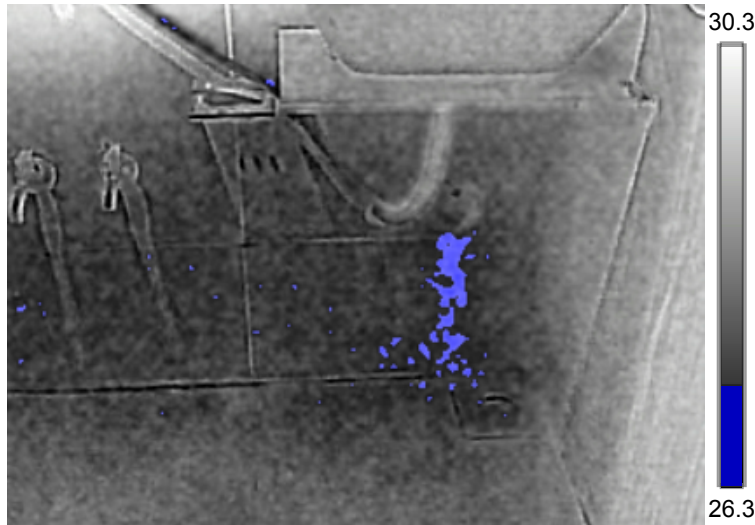
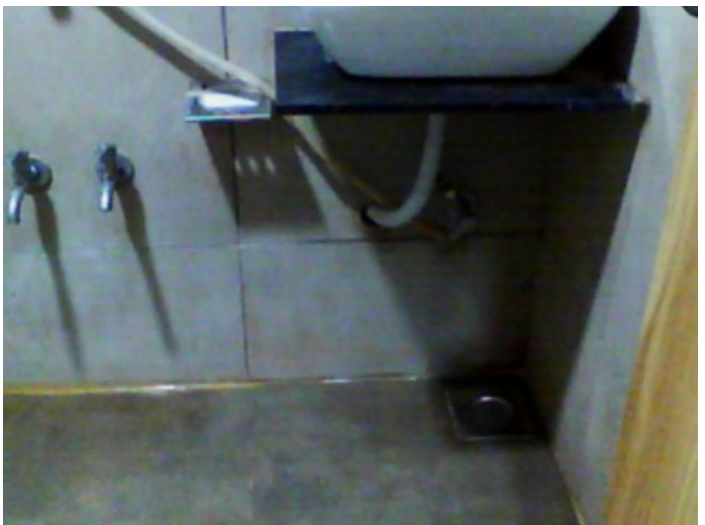
FLIR1275.jpg

**Water leakage due to hand wash basin.**

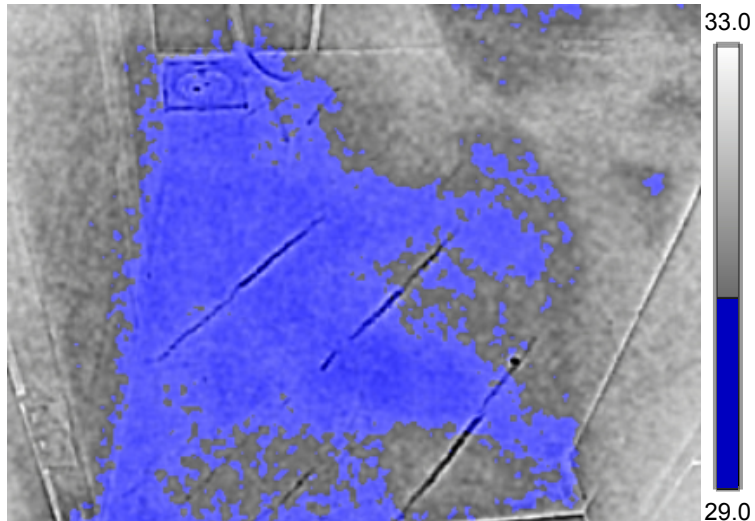
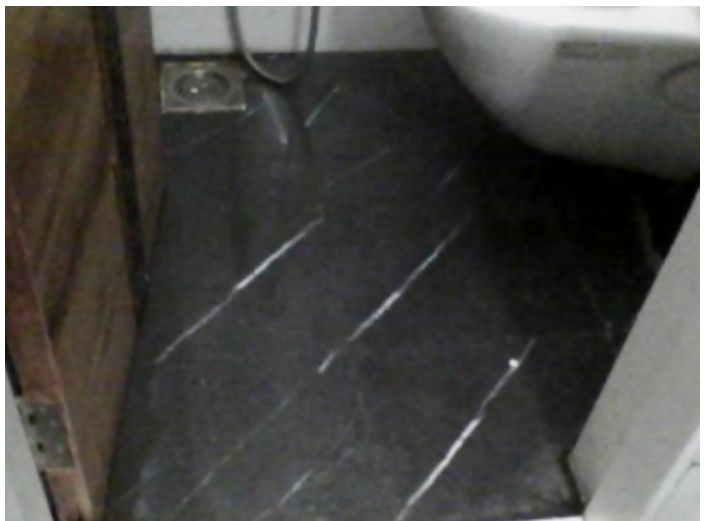
FLIR1252.jpg

**Washroom:- Water leakage due to sunken slab and floors.**
